FACILITY CONDITION ASSESSMENT

St. Matthew's Episcopal Church

Snellville, GA

March 2024

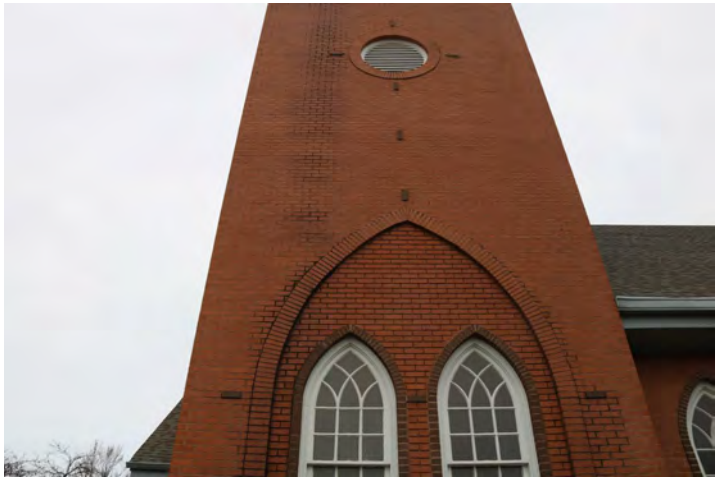
Accumulation of organic material on brickwork

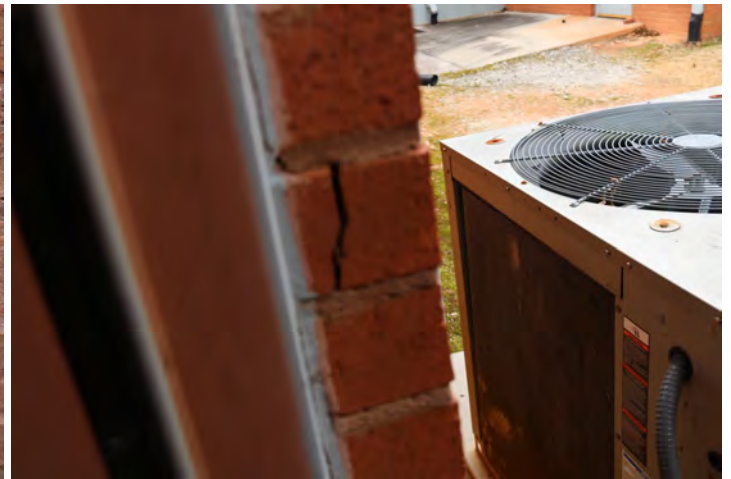
Compromised mortar joints and cracked bricks

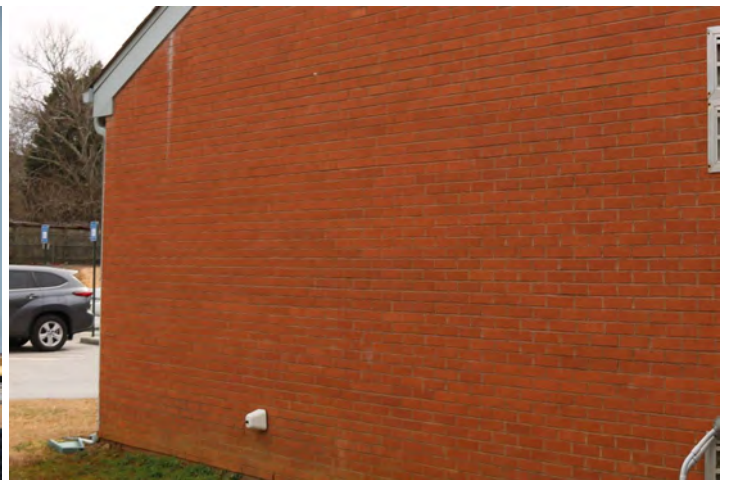
Significant crack at northwest corner of Parish Hall

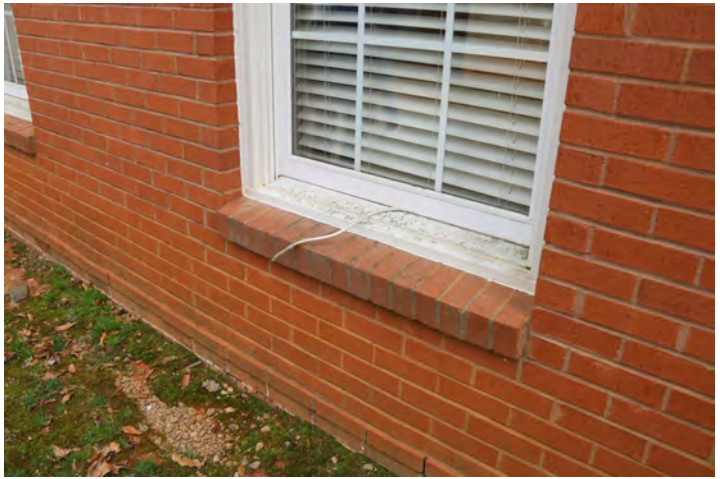
Deteriorating window frame

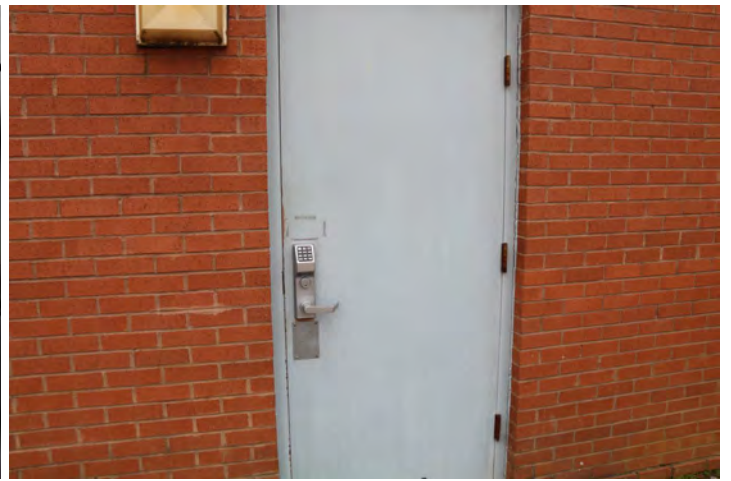
Replace deteriorated door

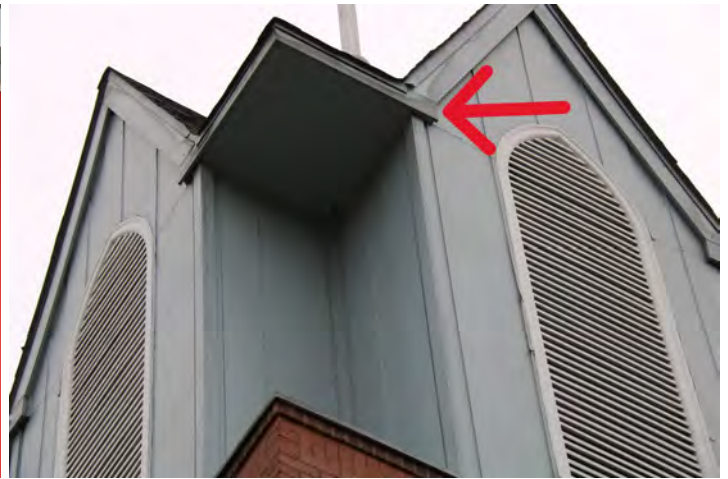
Incomplete repair requiring touch up paint

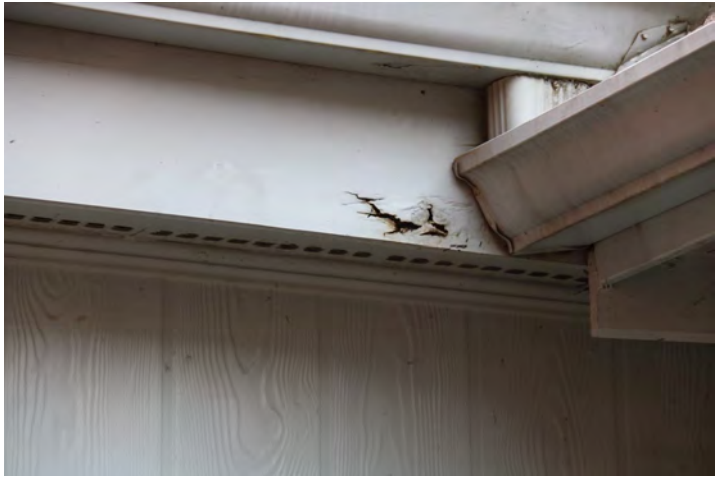
Deterioration on fascia and organic growth on masonry
due to lack of roof drain

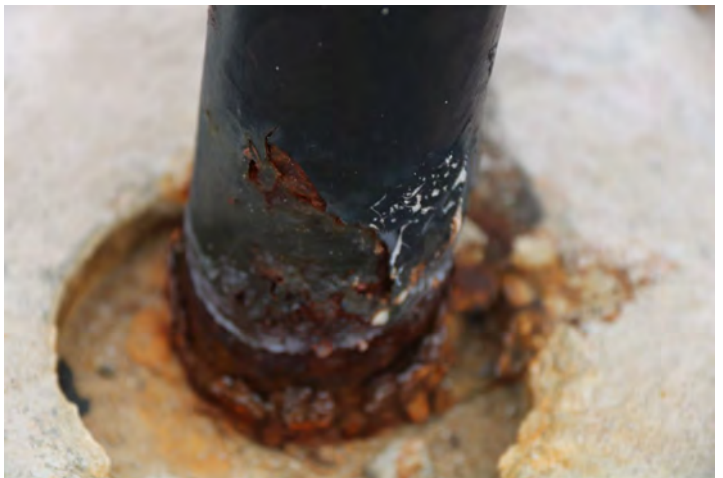
Rust on handrails

Furthermore, rust was noticed on handrails, necessitating repairs. Minor instances of surface rust can be remedied by sanding the affected area, applying rust converter, and then repainting the handrails. However, deeper areas of rust will likely require cutting out and replacing with new material.

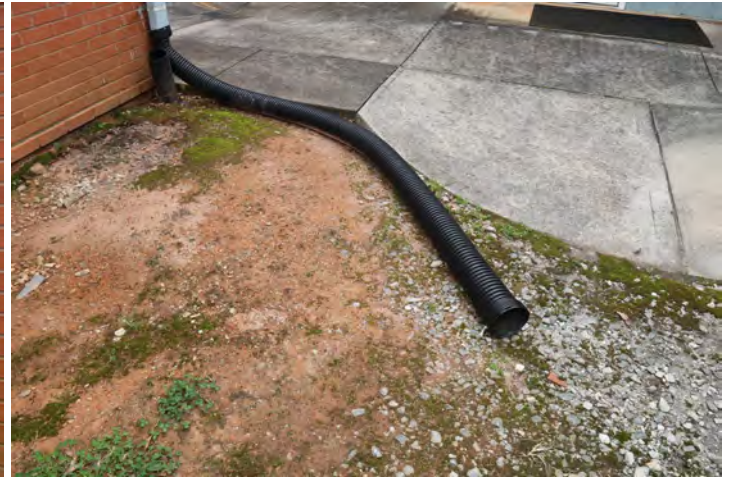
Ensure storm drainage is routed away from buildings

Furthermore, several areas were found to have inadequate drainage of stormwater away from the walls and foundations of the facilities. Addressing these concerns may involve cleaning out old underground drainage lines or installing new ones.

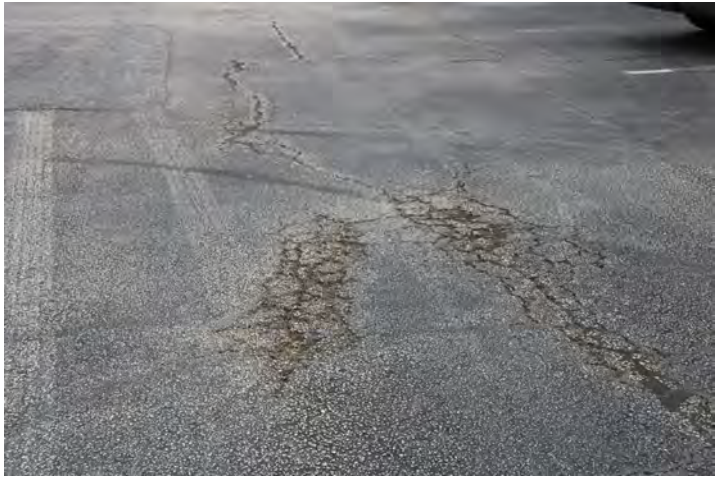
Repair compromised pavement at curbing

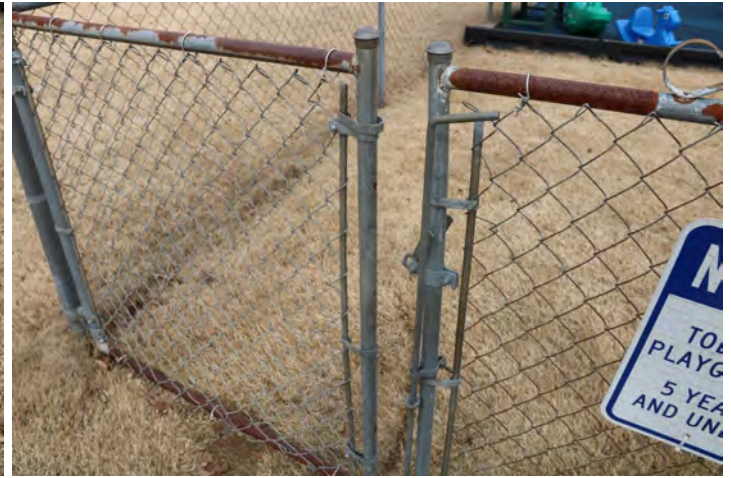
Damaged fencing along ground

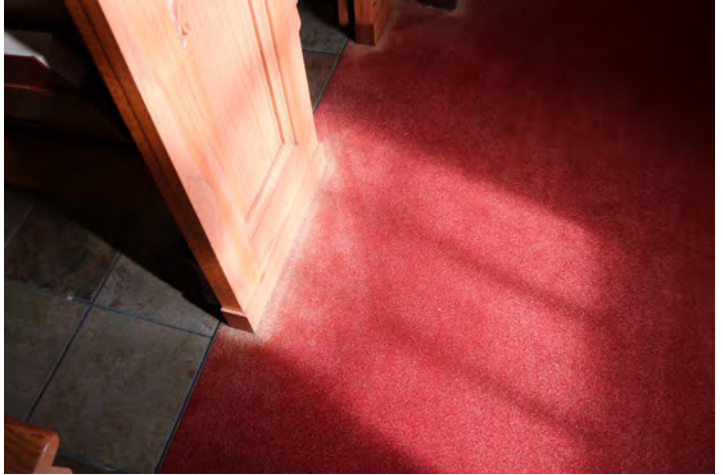
Stained and discolored carpet

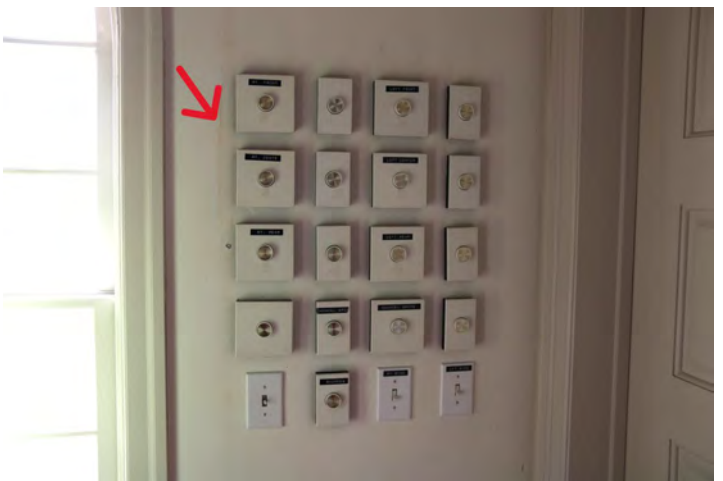
Wall damage in need of patching and painting

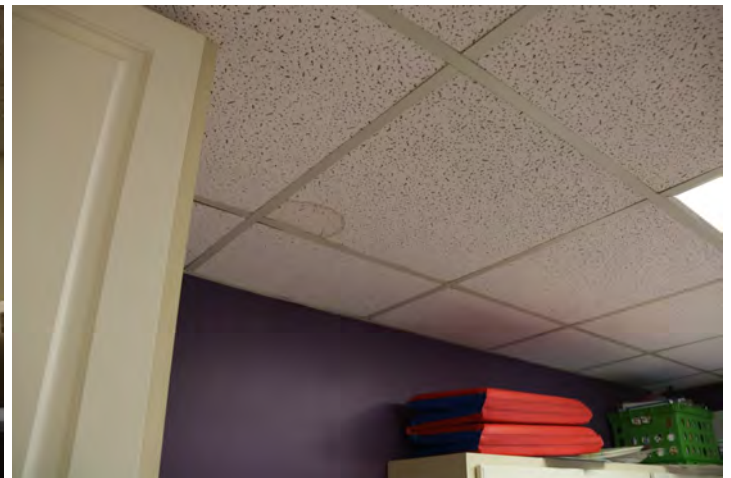
Ceiling tiles not firmly resting on grid

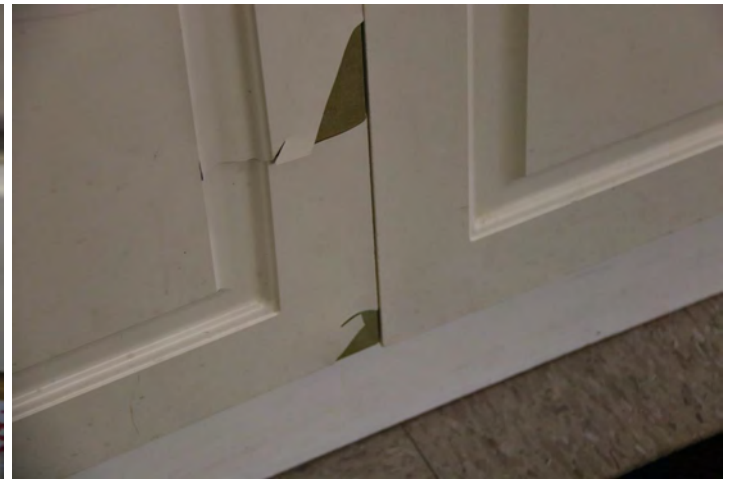
Broken laminate on drawer and door

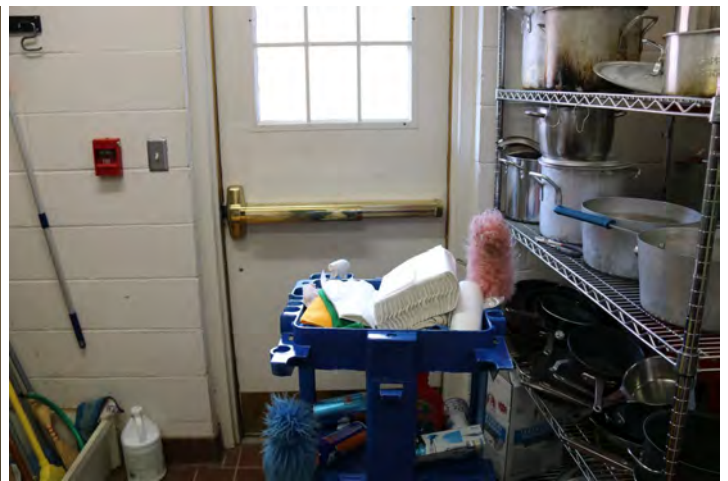
Emergency exit is obstructed

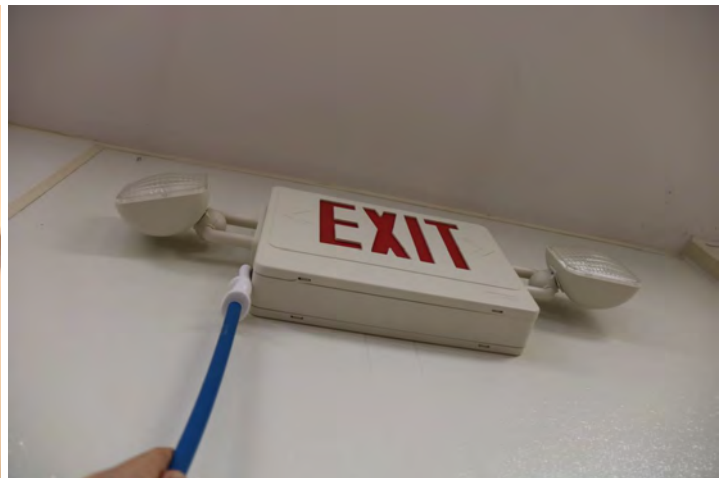
Emergency Exit light with failed back-up battery

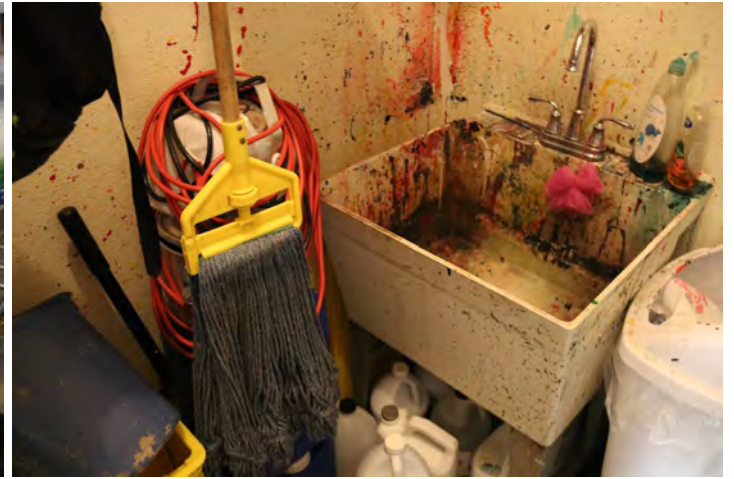
Improperly stored chemicals
