FACILITY CONDITION ASSESSMENT

St. Matthew's Episcopal Church

Snellville, GA

March 2024

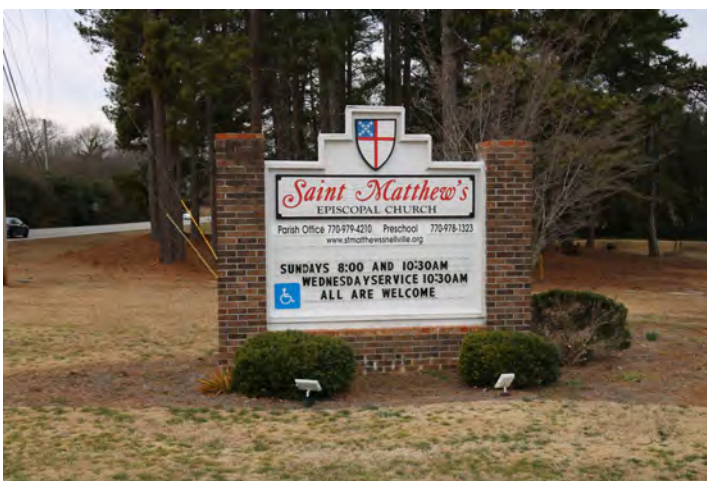
Signage is readable and unobstructed

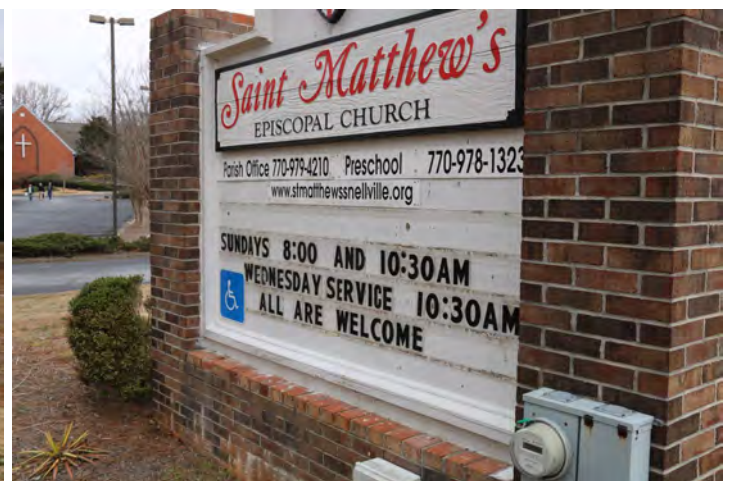
Signage displays buildup of soil and organic matter

The church's monument sign is clear and legible, free from obstructions. However, the overall structure requires cleaning, wood repair, and repainting to restore its appearance.

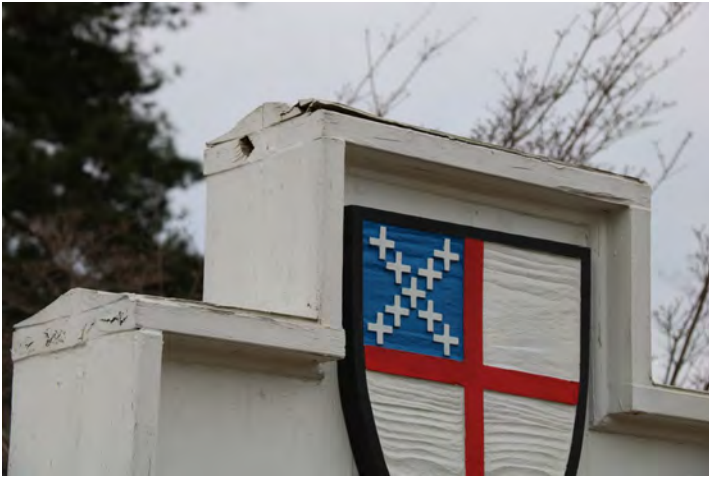
Wood trim on signage requires repair and repainting

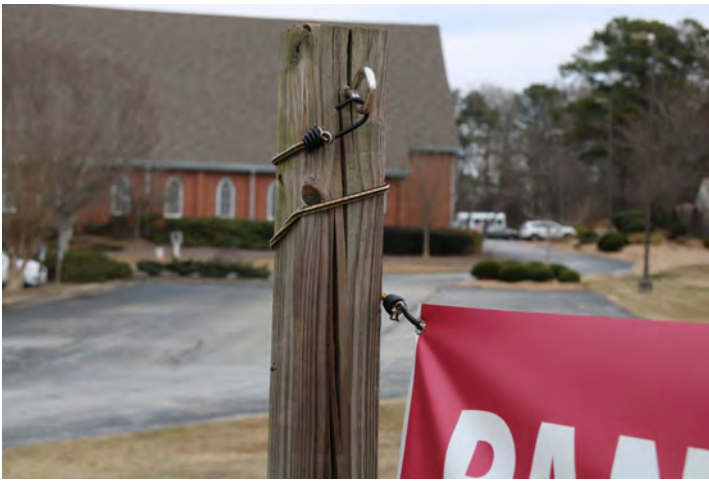
Utilizing temporary banners is an effective method to highlight church events as they are more eye-catching than updates on the monument sign's reader board. However, the sign posts holding these banners are weathered and cracked, necessitating replacement with pressure-treated and water-sealed lumber.

Sign posts are cracked and weathered

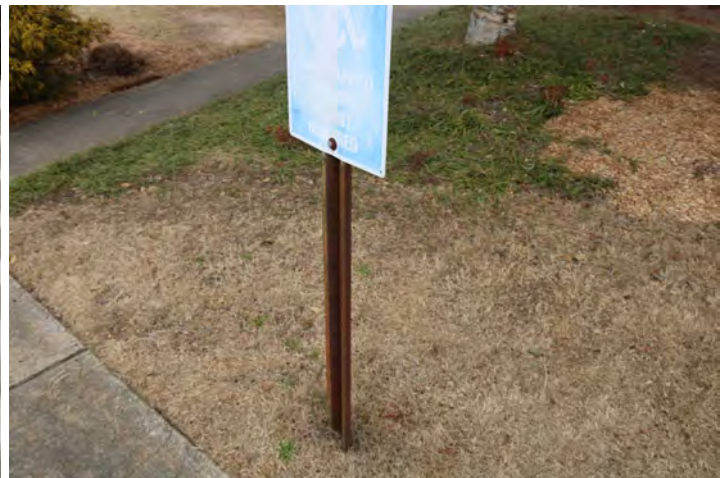
Two signs at St. Matthew's require replacement. The ADA sign in the south parking lot has faded, impeding readability, and the playground notice signage shows significant cracking.

ADA signage is faded and sign post is rusted

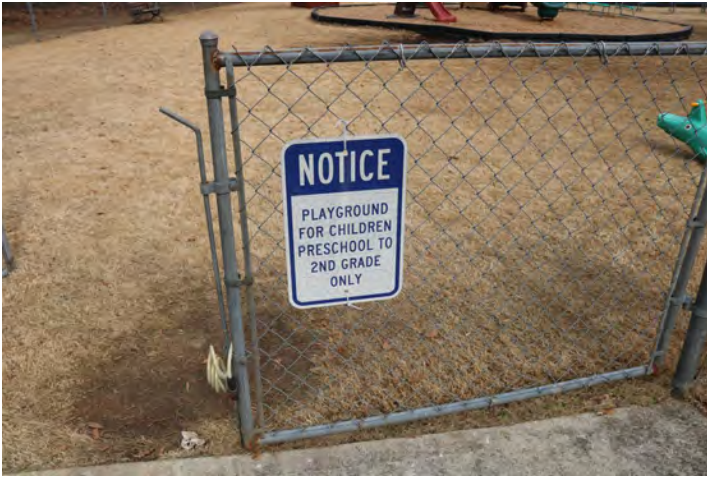
Playground sign has cracked appearance

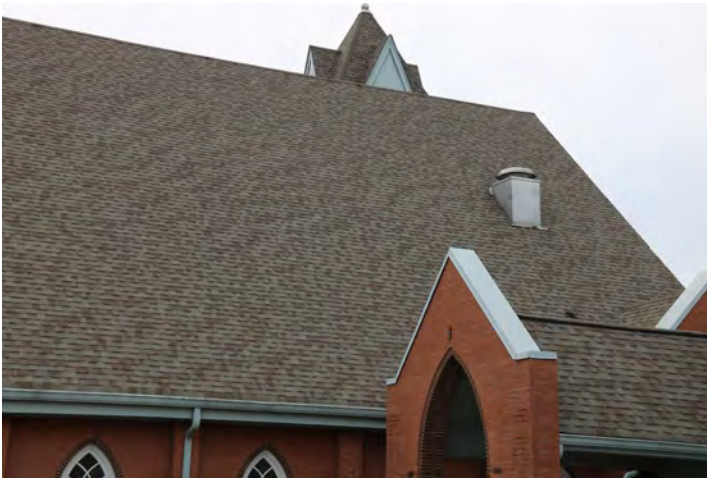
The church and office roofing is in good condition

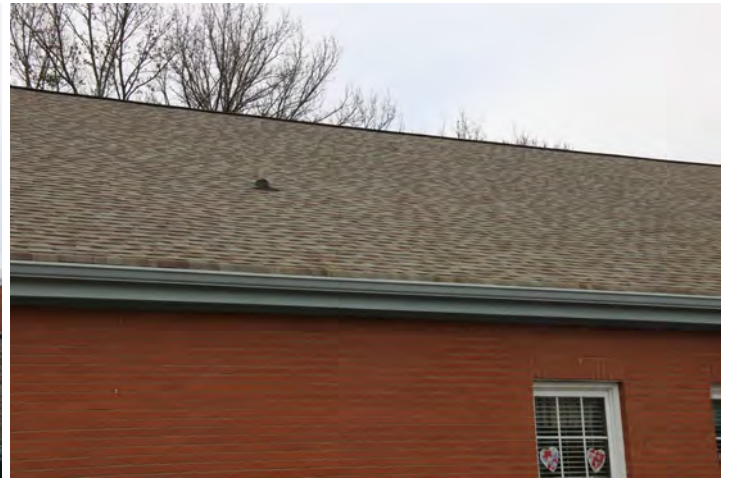
Dimensional shingle on Education Building is in good condition

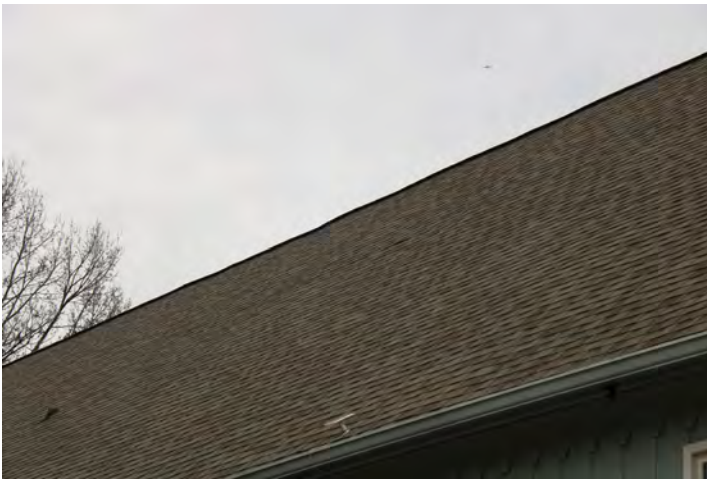
Parish Hall roofing showed no deficiencies

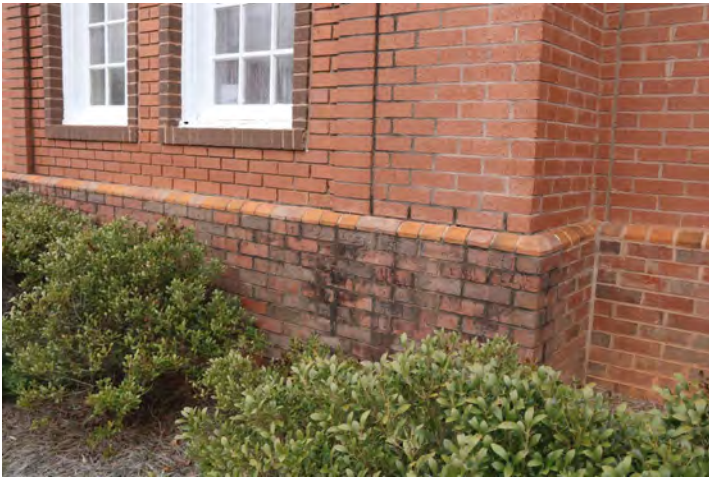
Accumulation of organic material on brickwork

The exterior masonry walls of both the Church and Parish Hall buildings exhibit signs of organic growth and discoloration, as well as identified issues in the masonry and compromised mortar joints. Additionally, soil accumulation was observed on the lower walls of the storage shed near the playground. To uphold the integrity of the building envelope, prevent further damage, and enhance the overall appearance of the facilities, adopting a comprehensive approach is advisable. This involves cleaning, repairing cracks, and conducting tuckpointing on damaged mortar joints.

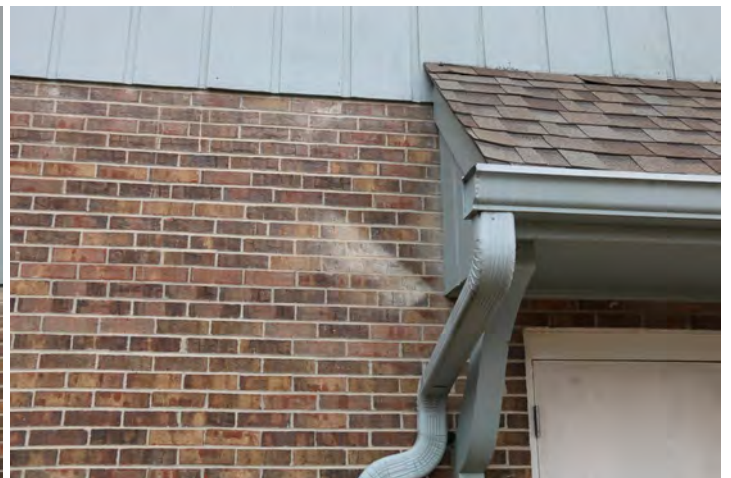
Discoloration of brickwork

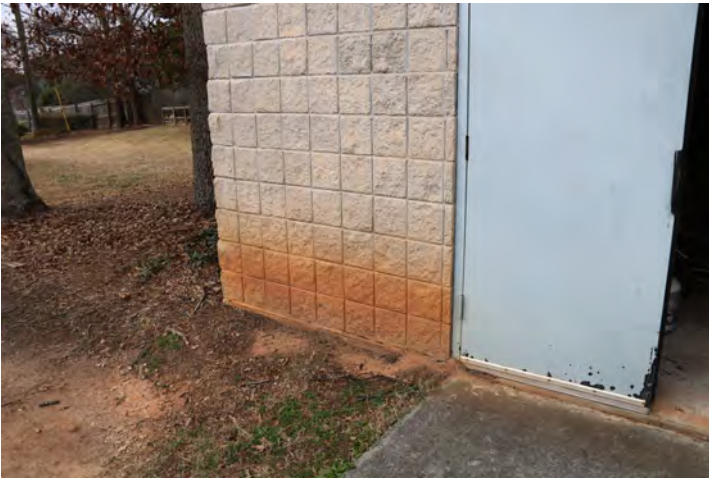
Soil accumulation on CMU walls

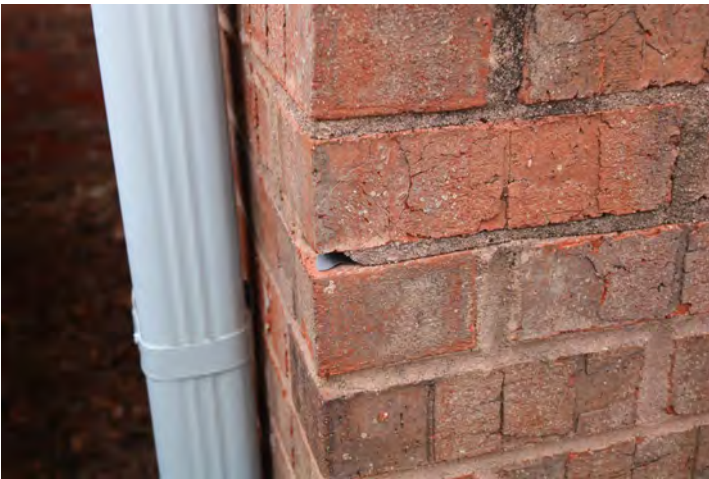
Compromised mortar joints and cracked bricks

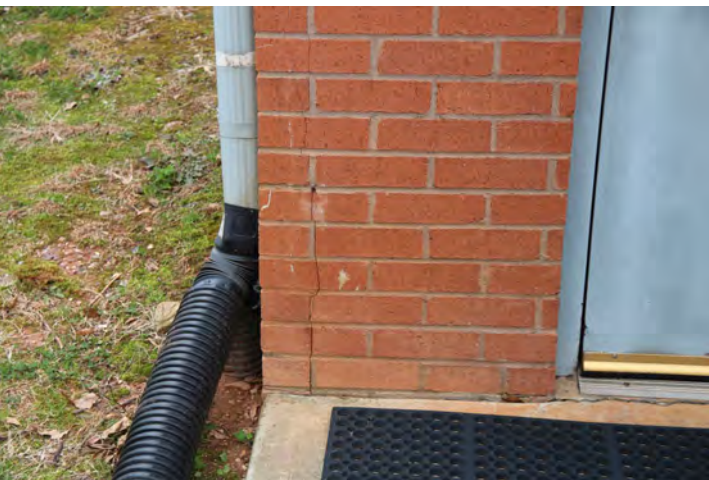
Significant crack at northwest corner of Parish Hall

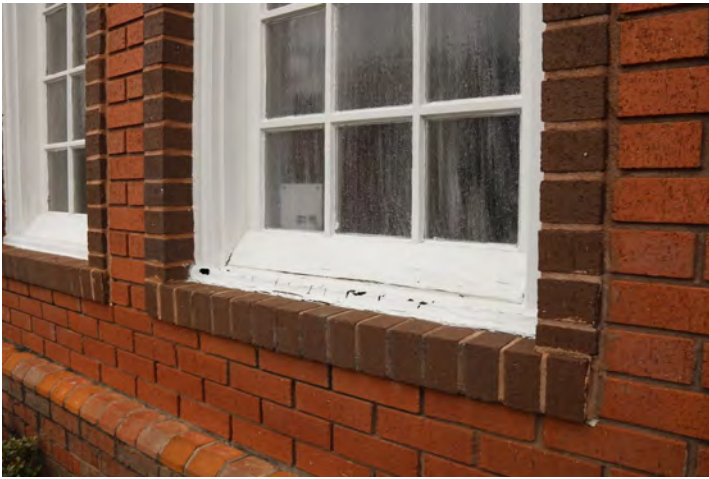
Deteriorating window frame

The windows in the Church Building at St. Matthew's showed signs of deterioration in the window frames and compromised glazing with visible cracking. Therefore, refurbishment is necessary, including the replacement of damaged framing, reglazing, and repainting as needed. Additionally, many windows in the Education Building displayed organic growth that requires cleaning, along with several seals in need of replacement.

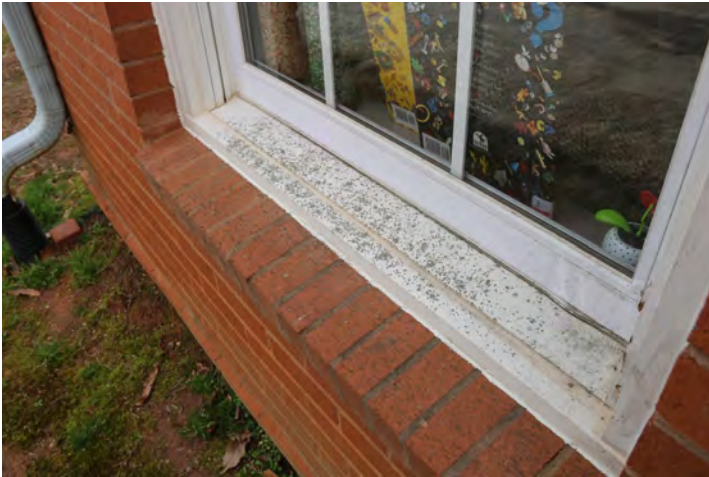
Organic growth on window frame

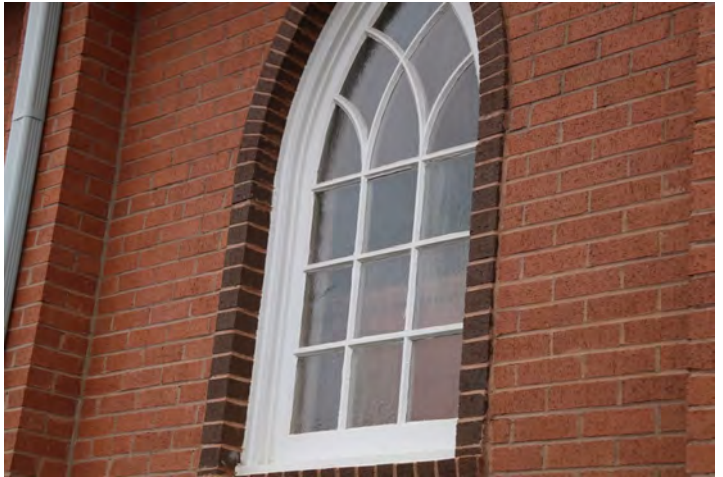
Sanctuary windows display compromised glazing

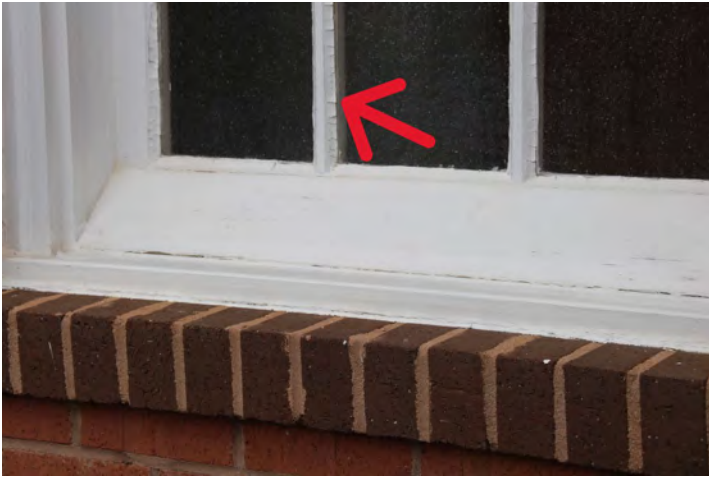
Compromised glazing putty

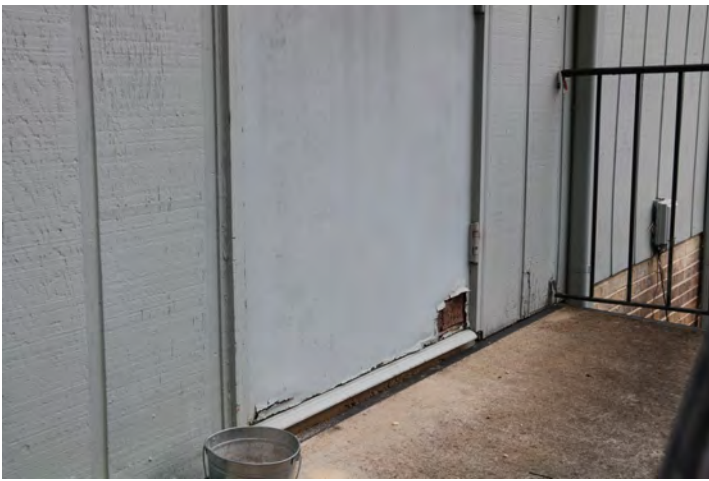
Replace deteriorated door

Several doors were found to require cleaning and repainting, with one door showing significant deterioration at the bottom, necessitating replacement.

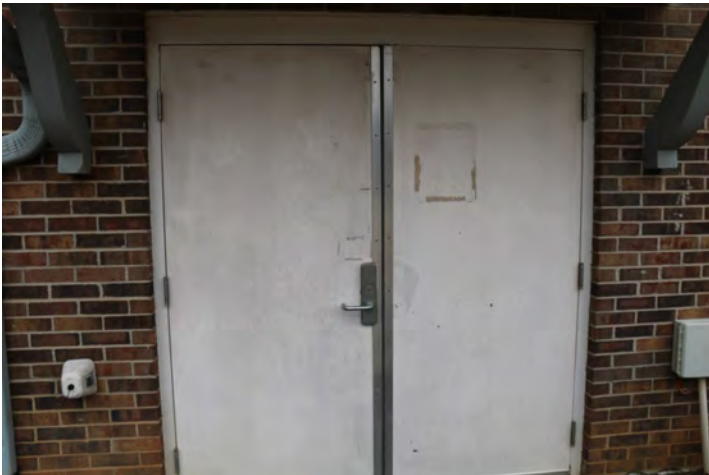
Clean doors and repaint as necessary

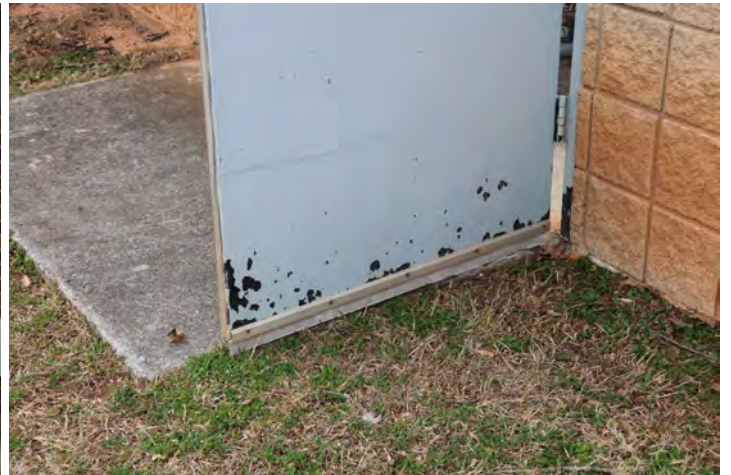
Sand damaged area and repaint door

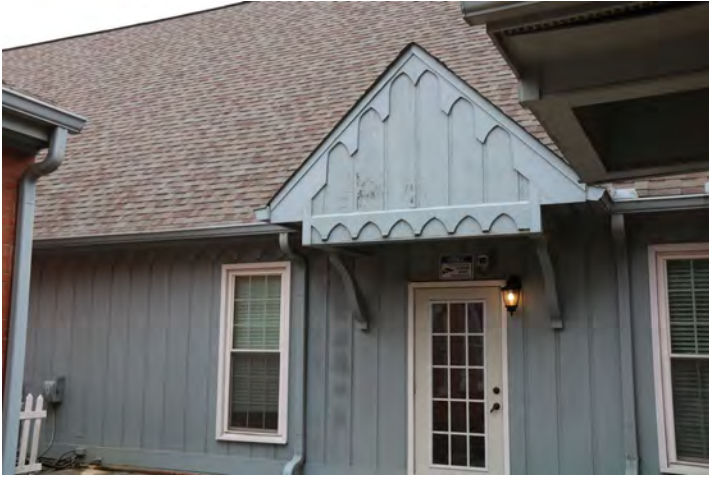
Siding shows soil accumulation and peeling paint

During the assessment, deficiencies were identified with the siding and wood trim on the St. Matthew's facilities. Resolving these issues entails cleaning accumulated soil from the siding, repainting areas with peeling paint, replacing the wood trim around the attic vent on the east wall of the Office Building, and repairing and repainting fascia in several areas around the facility. Another area of concern is the deteriorating fascia and accumulated organic material observed on the brickwork of the east face of the Church Building where the eaves meet with brick walls without the benefit of any type of drain to channel stormwater away from the walls.

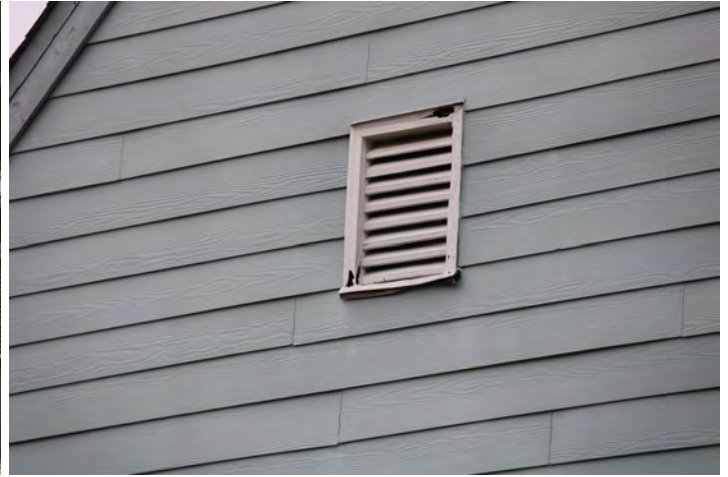
Frame of vent is disintegrating

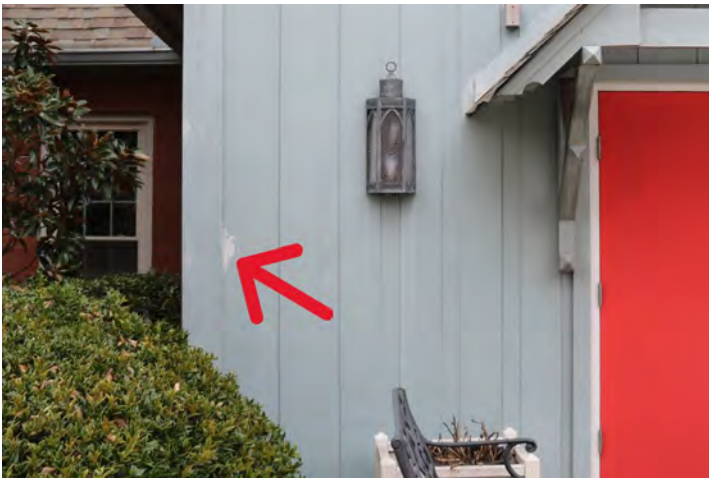
Incomplete repair requiring touch up paint

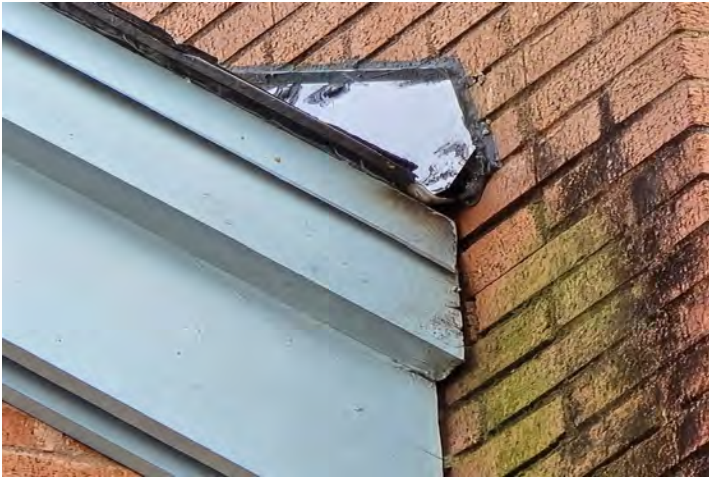
Deterioration on fascia and organic growth on masonry
due to lack of roof drain

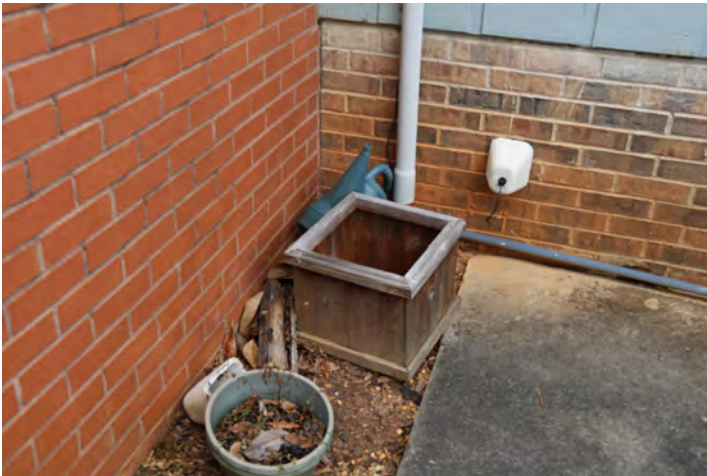
Remove debris and equipment from along building walls

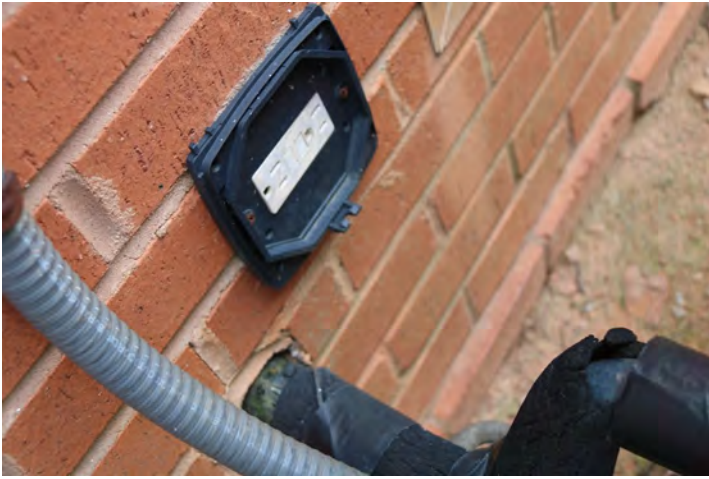
Ensure all exterior outlets have weatherproof covers

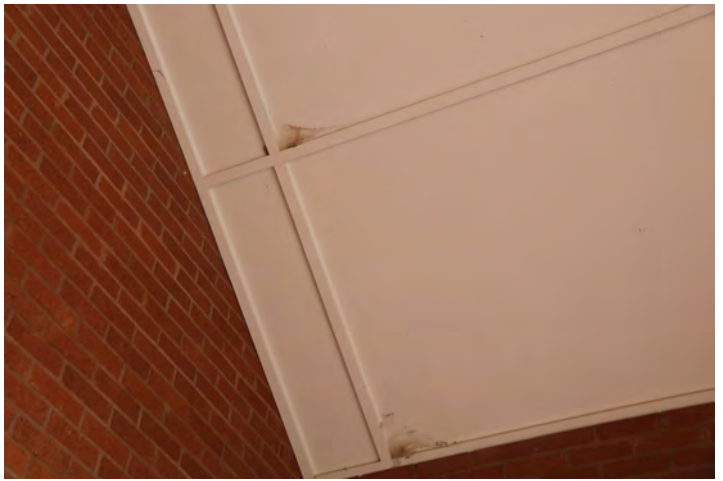
Clean webs from ceiling areas

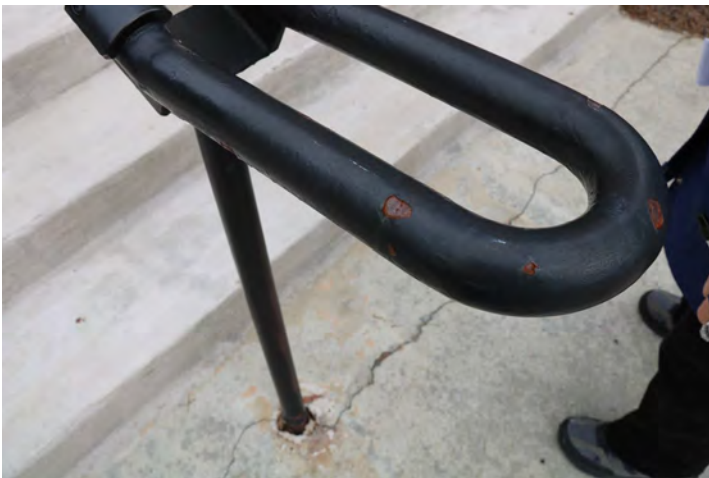
Rust on handrails

Furthermore, rust was noticed on handrails, necessitating repairs. Minor instances of surface rust can be remedied by sanding the affected area, applying rust converter, and then repainting the handrails. However, deeper areas of rust will likely require cutting out and replacing with new material.

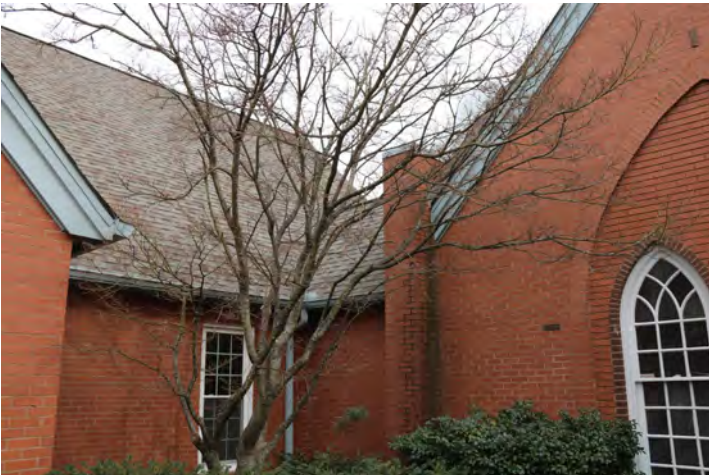
Trim tree branches back away from walls and roof areas

The landscaping at St. Matthew's is generally well-maintained, although a few areas could benefit from a thorough cleanup of debris and the trimming of bushes, trees, and shrubs to ensure a minimum distance of 36 inches from walls and roofs. These measures serve multiple purposes: improving building security, facilitating easier maintenance access, minimizing wear on masonry joints, deterring insect and rodent nesting, and ultimately enhancing the overall aesthetic appeal of the facilities.

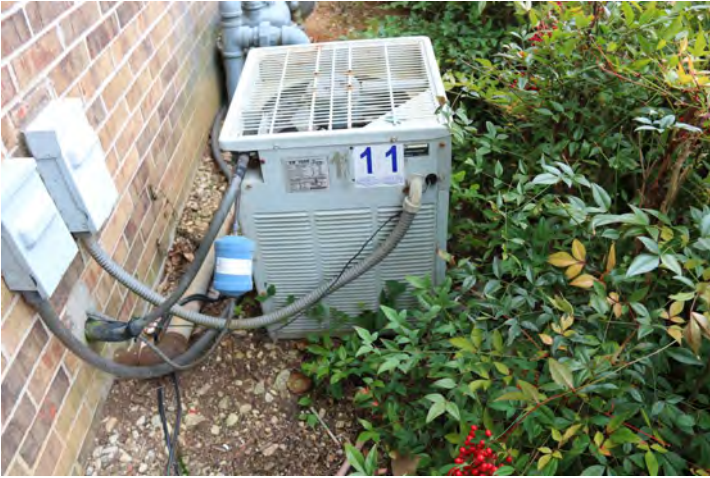
The area around HVAC units is free from vegetation

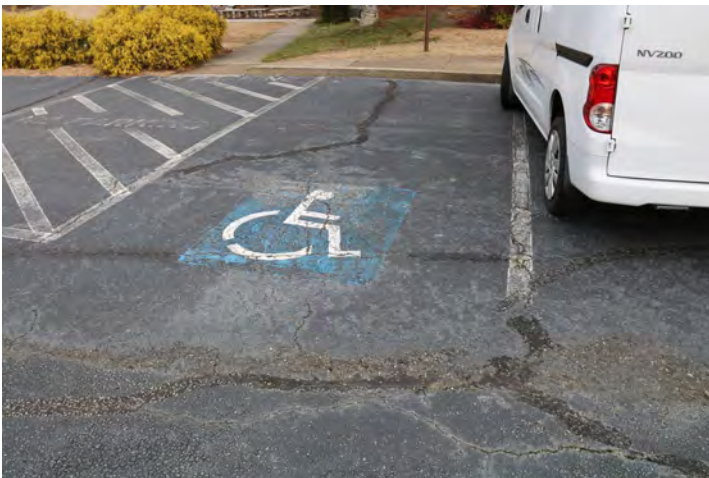
Painted ADA stall identification is fading

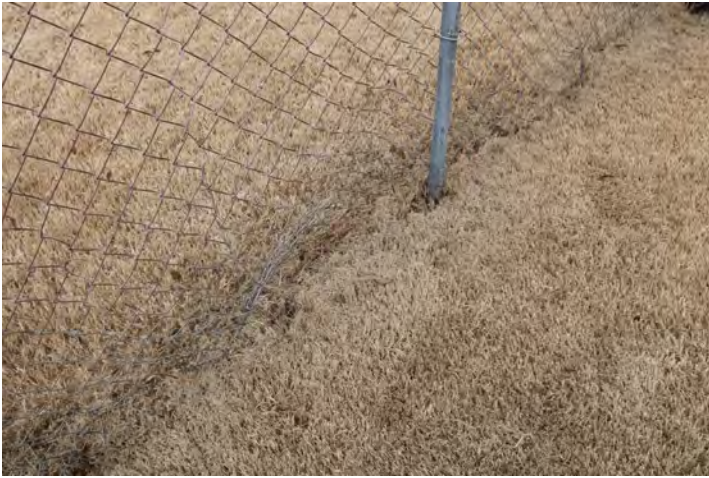
Damaged fencing along ground

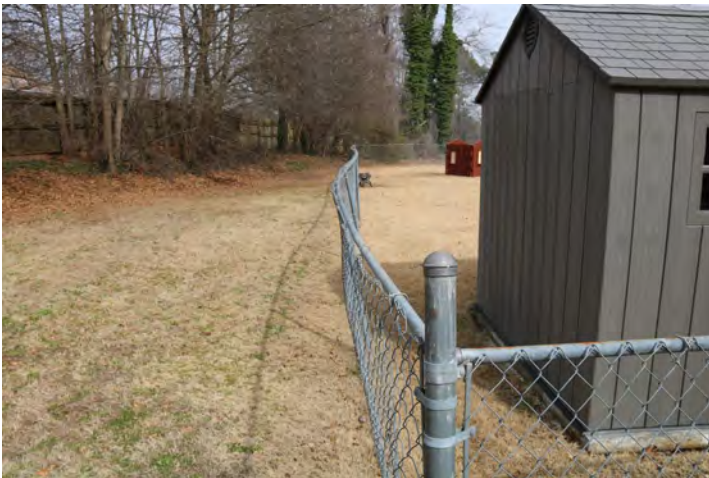
Fence posts appear loose

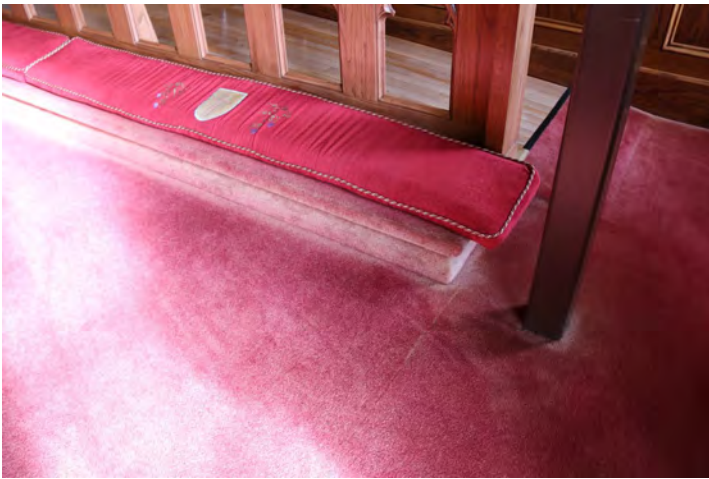
Discoloration of carpet likely due to inadequate vacuuming

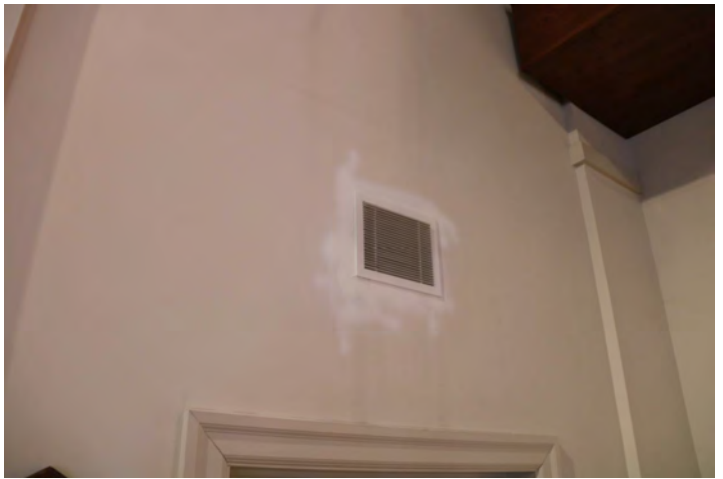
Incomplete wall repair

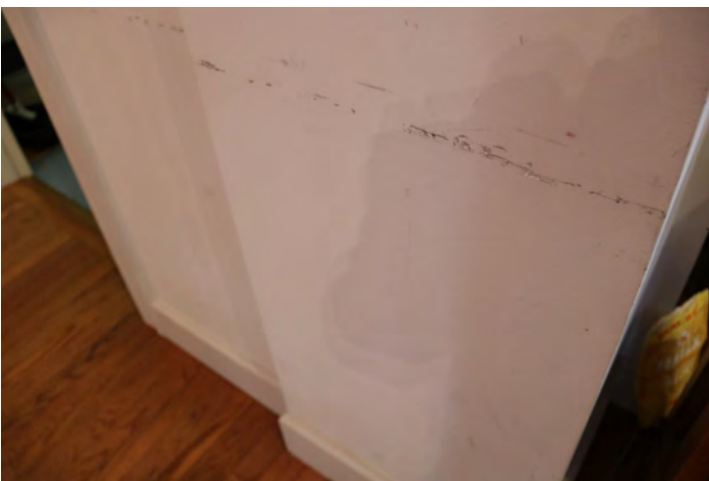
Wall damage in need of patching and painting

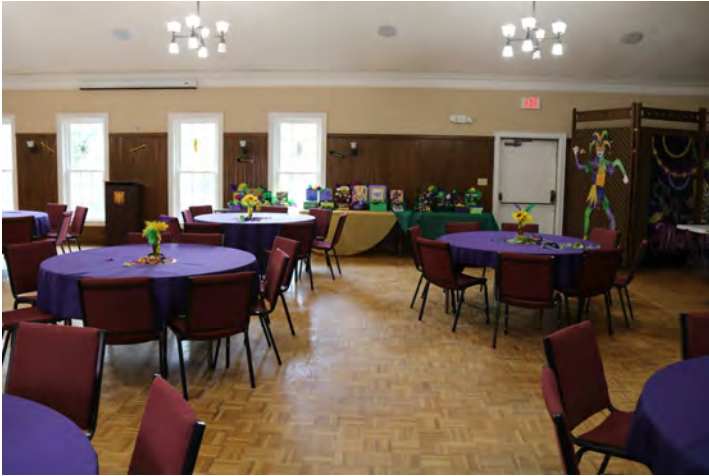
Multiple issues were identified in the Parish Hall, such as worn parquet flooring showing signs of wear and beyond its expected lifespan, scratches on wood wainscot needing touch-up, mismatched ceiling repairs, a door requiring cleaning and painting, and the need for regular cleaning of ceiling vents. Additionally, several notes were noticed taped to one door, and we recommend replacing them with more permanent signage.

Parquet flooring appears worn and dull

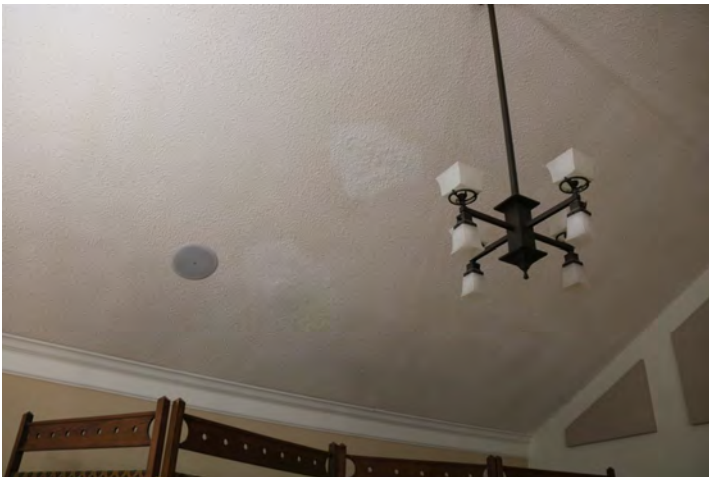
Mismatched ceiling repairs

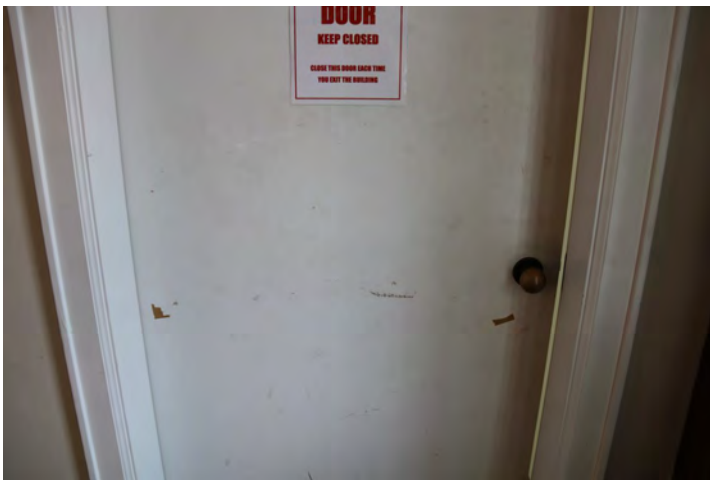
Dirty door with chipped paint

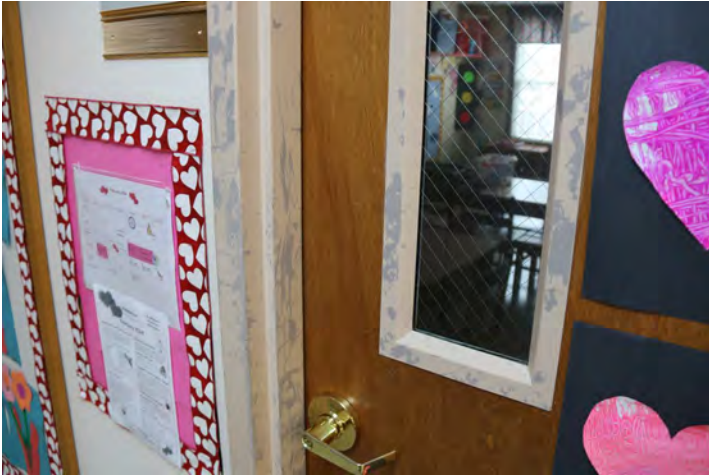
Peeling paint on door and relite frames

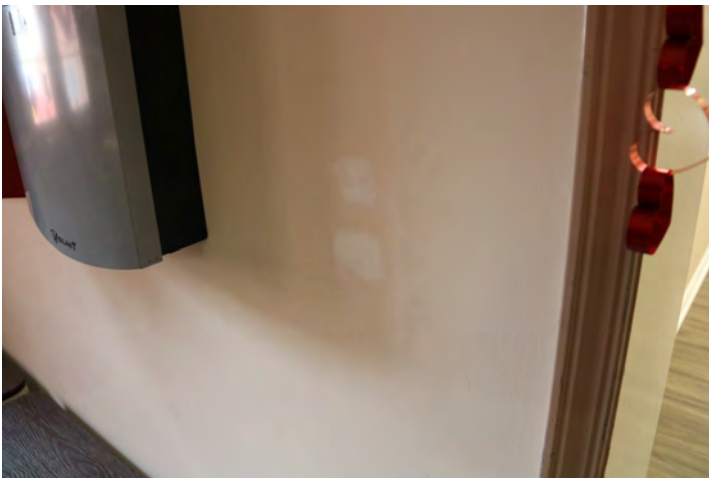
Incomplete wall repair

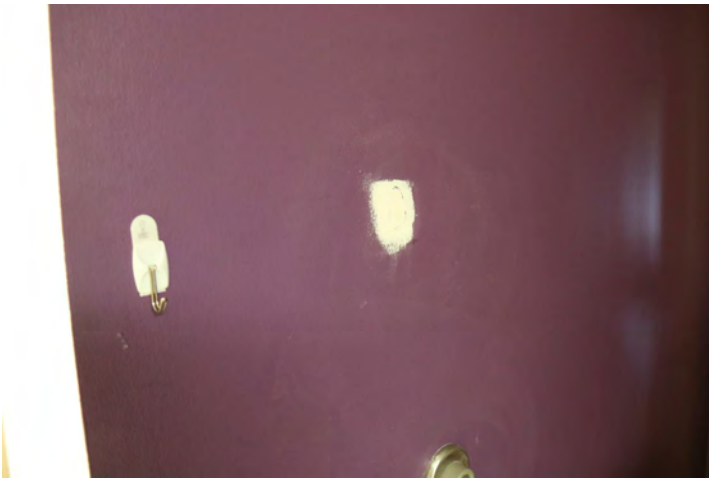
Incomplete wall repair

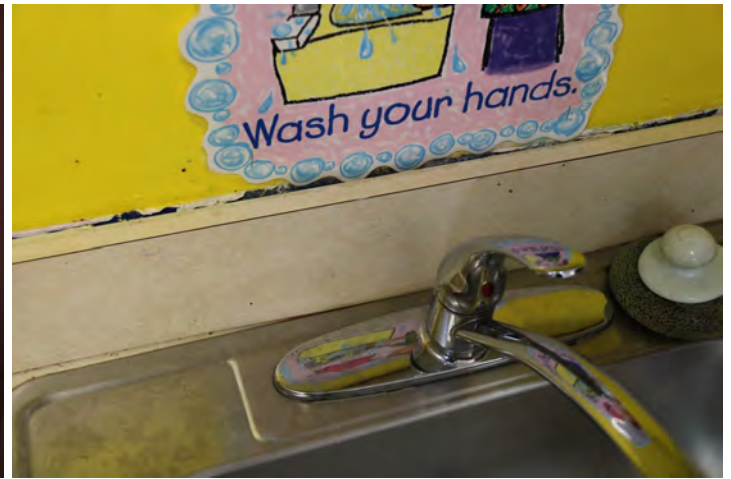
Dirty sink area and splash panel is coming loose from wall

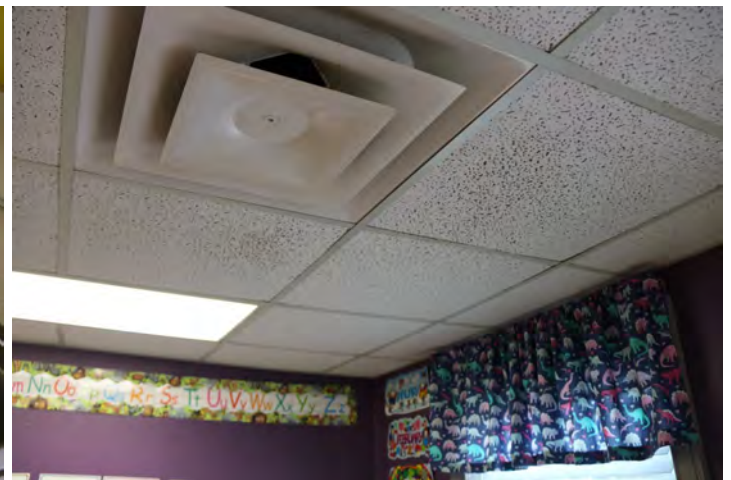
Dirty ceiling vent and tiles

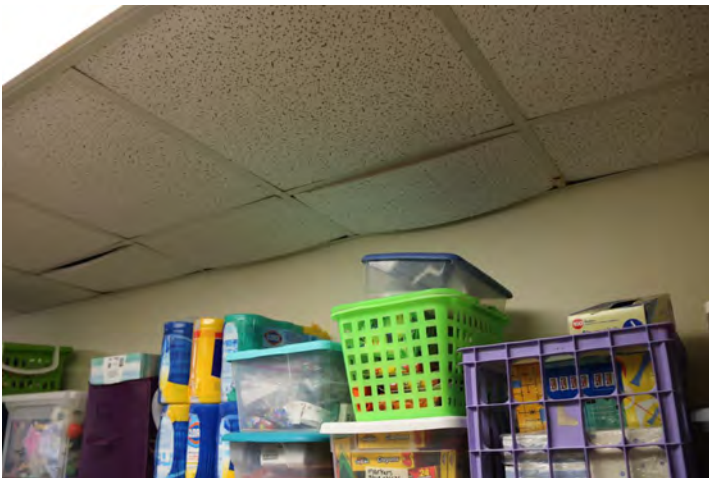
Ceiling tiles not firmly resting on grid

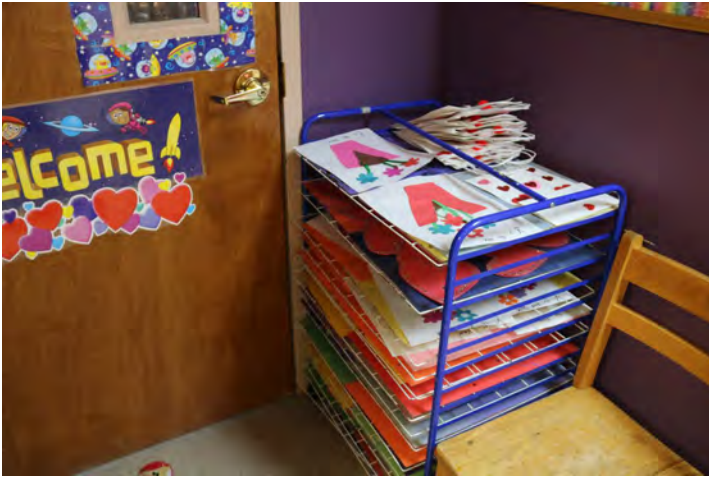
Art drying rack may inhibit access to door

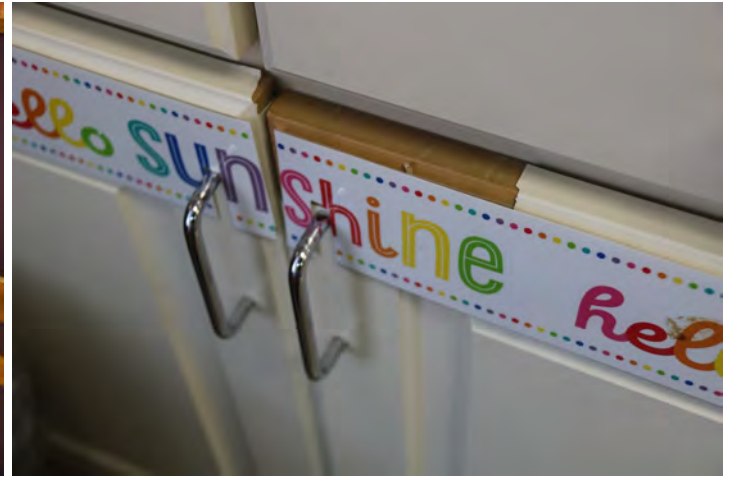
Damaged laminate on cupboard doors

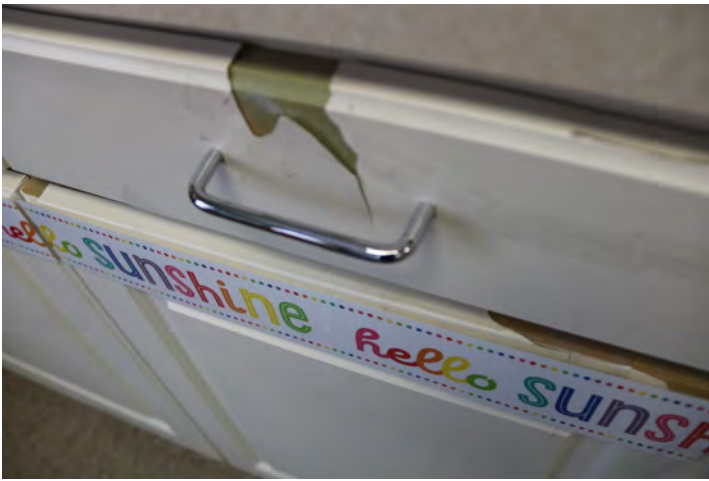
Broken laminate on drawer and door

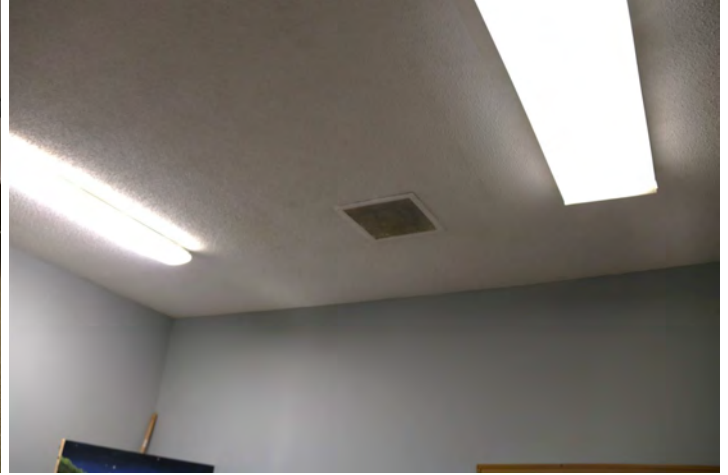
Ceiling vent in need of cleaning

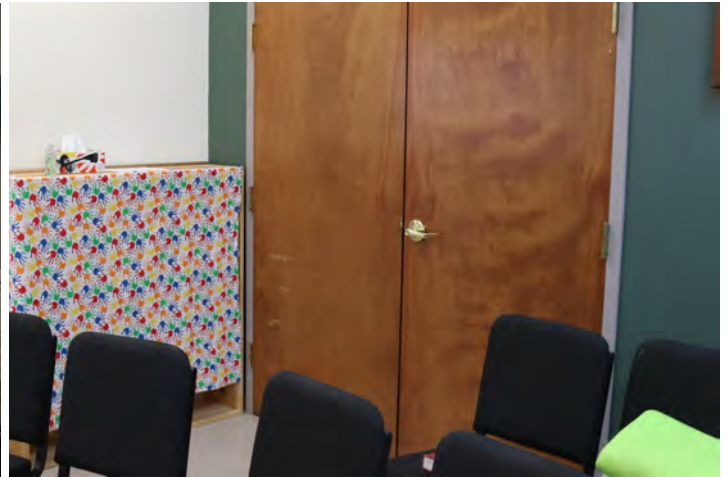
Scratched finish on doors

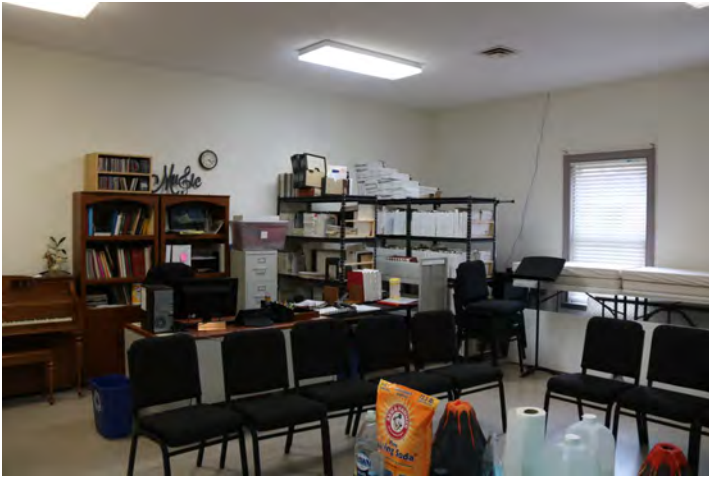
Tall shelving should be firmly secured to the wall

General Safety - Tall shelving (over four feet tall) was observed in several areas throughout the facilities that did not appear to be securely anchored to the wall. To ensure safety and prevent potential tip-over injuries, it is essential to properly fasten tall furnishings such as cabinets and shelves to the wall.

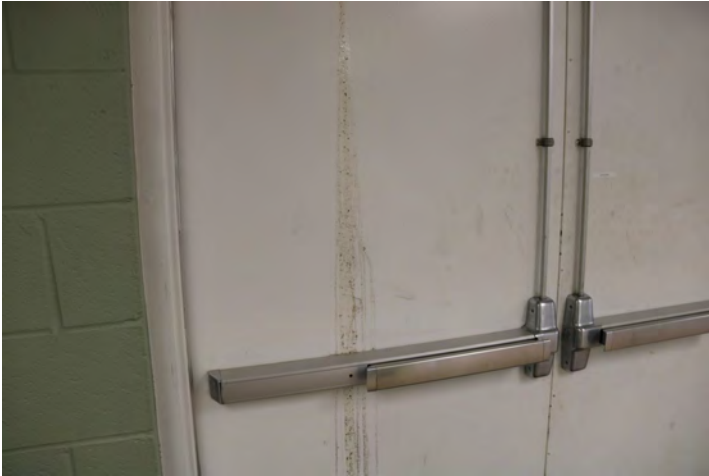
Cleaning door closer oil from door

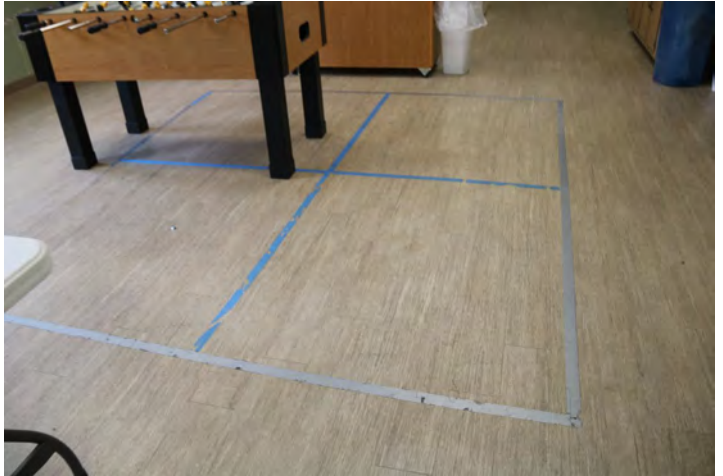
Remove worn tape and adhesive residue from flooring

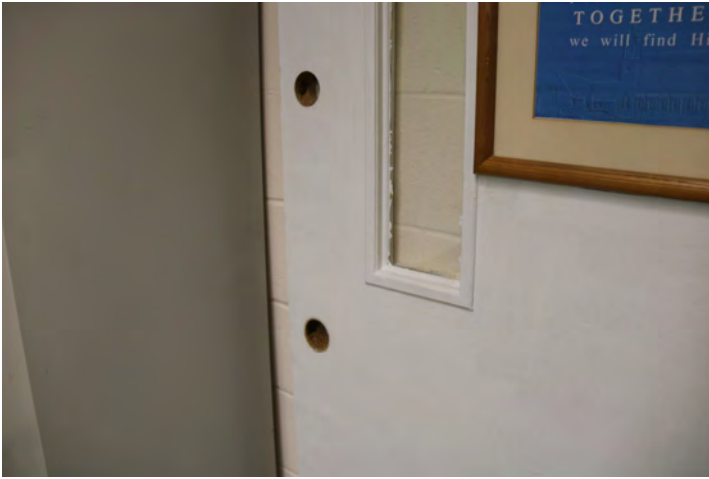
Missing door handle and lock

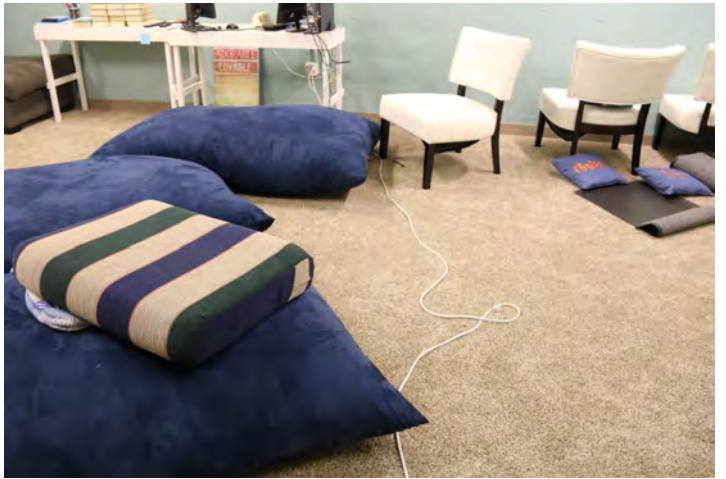
Additionally, a long extension cord was found stretched across the floor of the youth area, posing a trip hazard and potential fire hazard depending on its usage. We strongly recommend removing the extension cord, if possible, and utilizing the nearest outlet for electrical equipment.

Extension cord across room is a trip hazard

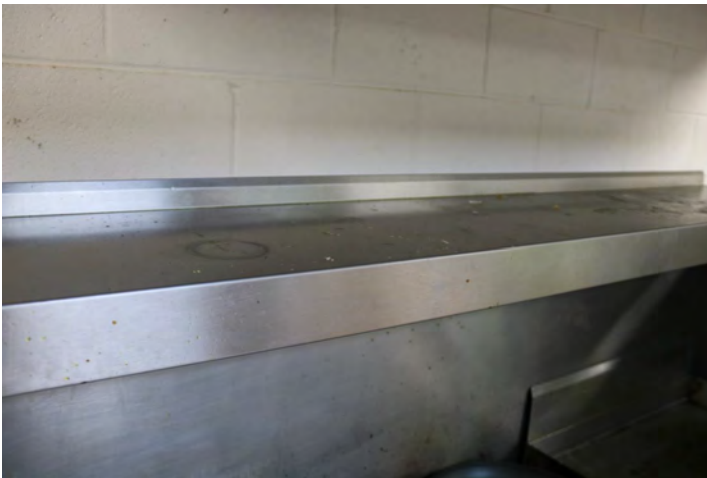
Clean dust and grease from shelf above stove

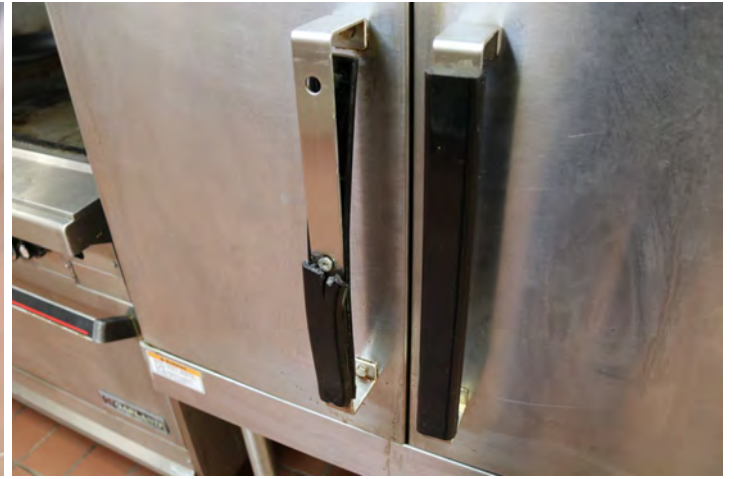
Clean exterior and replace broken handle

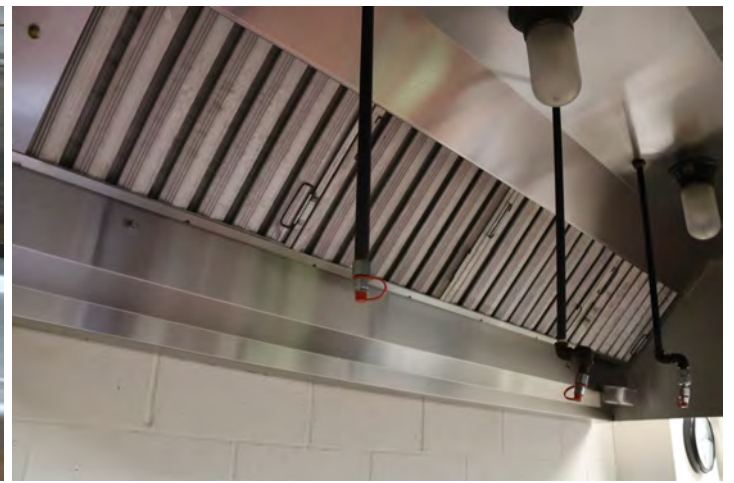
Vent hood in need of deep cleaning

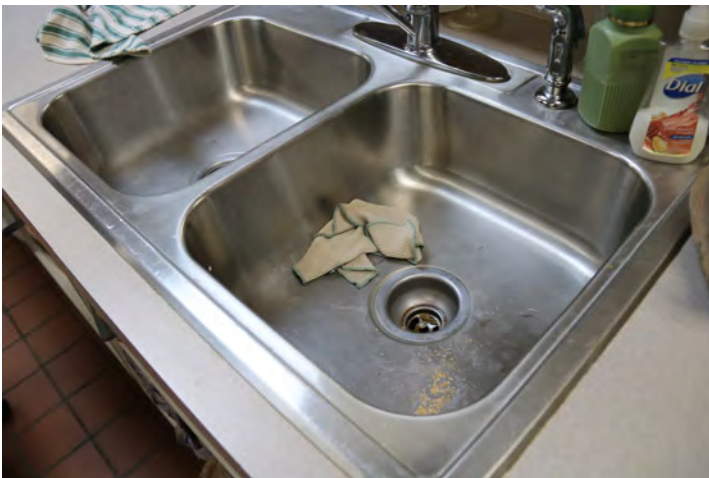
Dirty sink area

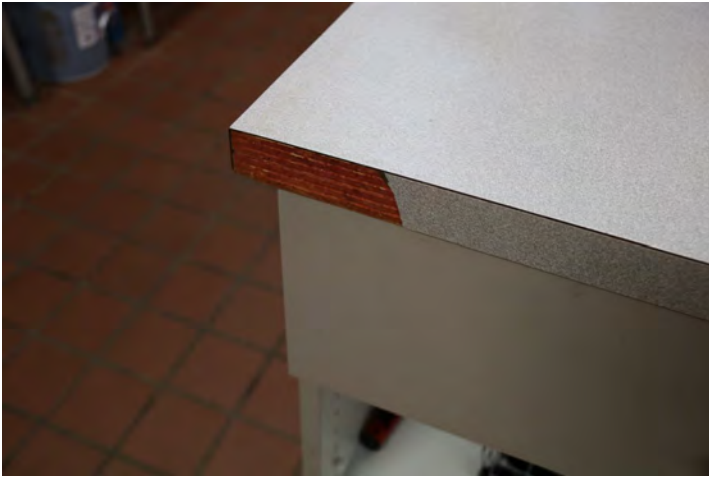
Broken laminate on counter edge

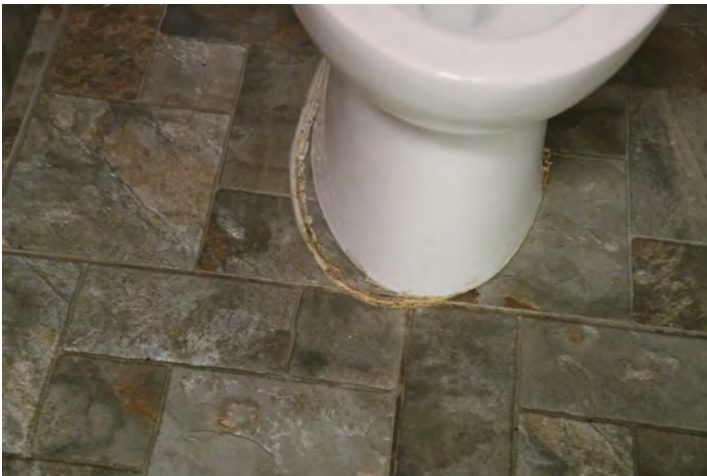
Reposition toilet and recaulk
