FACILITY CONDITION ASSESSMENT

St. Matthew's Episcopal Church

Snellville, GA

March 2024

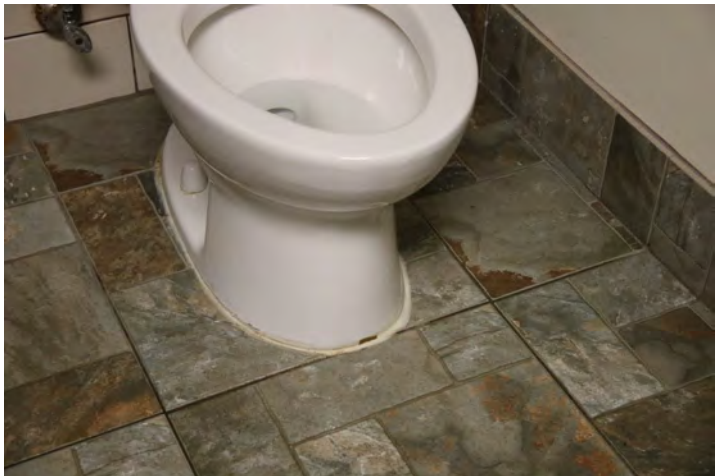
Dirty flooring and base of toilet

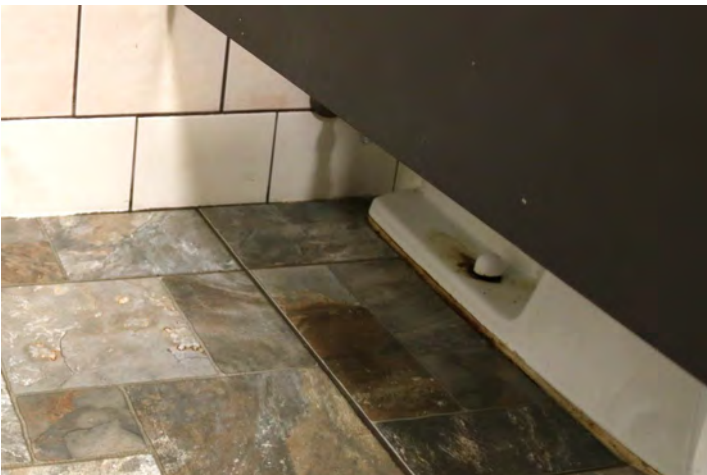
Dirty base of toilet and flooring

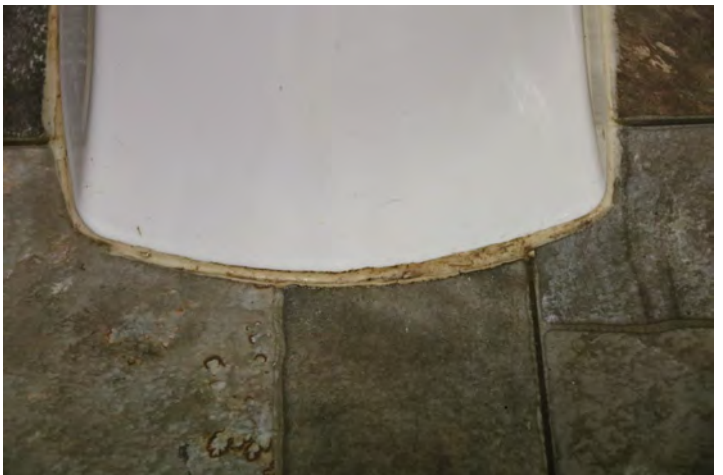
Dirty grout and caulking

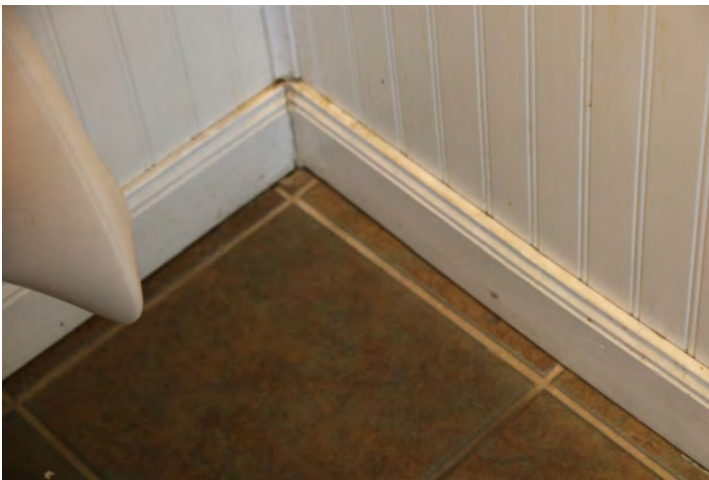
Accumulation of soil on base boards

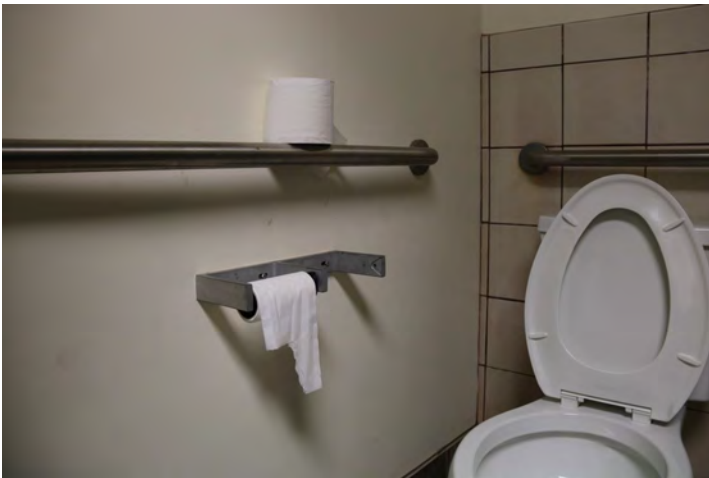
Missing roller on toilet paper dispenser

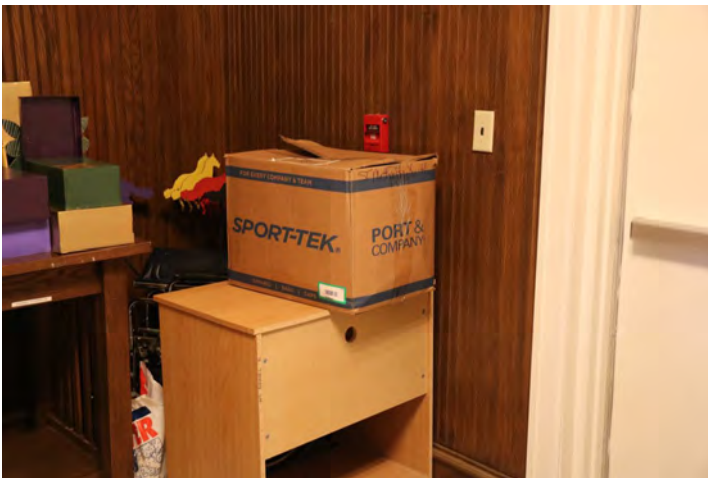
Fire pull station is obstructed

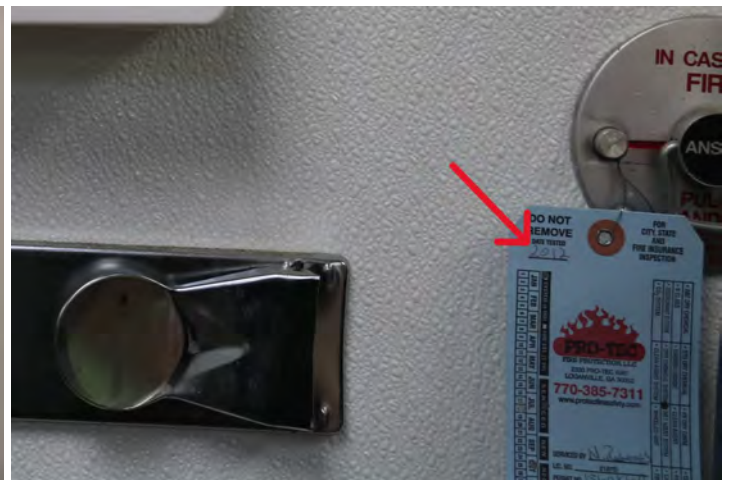
ANSUL fire suppression last inspected in 2012

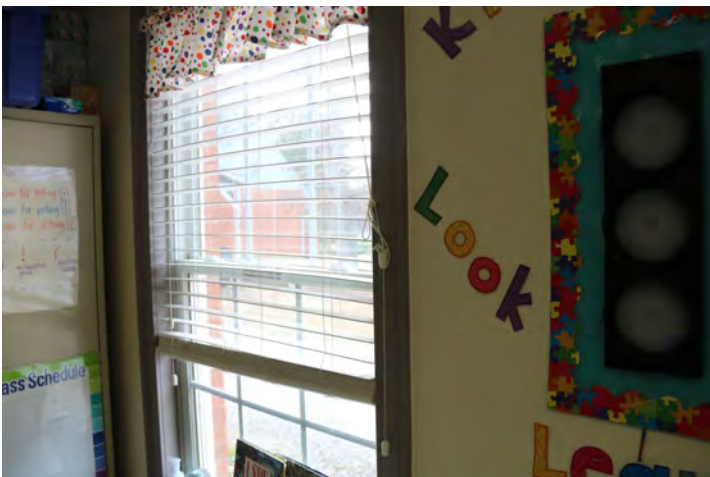
Ensure that cords for blinds are out of reach of children

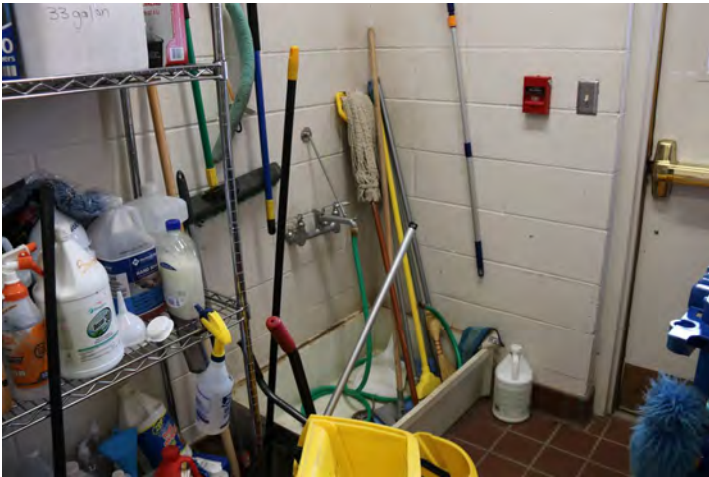
Hang cleaning implements hung on wall

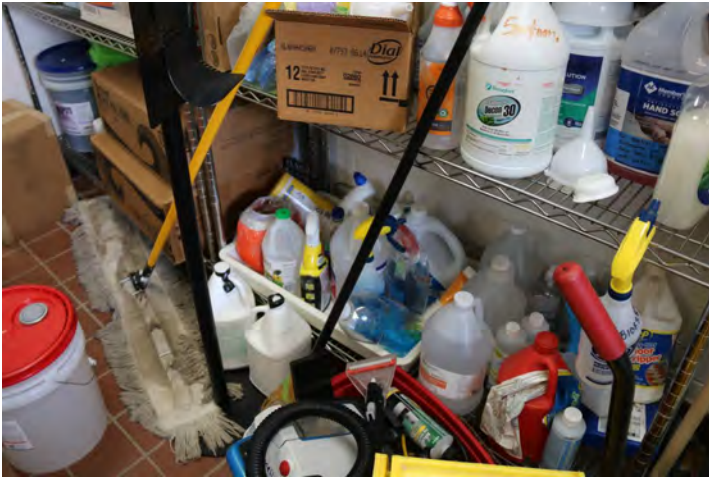
No Safety Data Sheets (SDS) were observed during the inspection and improper labeling and storage of chemicals was noted. Proper labeling and storage are critical to prevent adverse and hazardous reactions. It is essential to ensure that chemical bottles are labeled with manufacturer-provided labels containing all necessary cautions and safety information.

Improperly stored chemicals
