FACILITY CONDITION ASSESSMENT

St. Matthew's Episcopal Church

Snellville, GA

March 2024

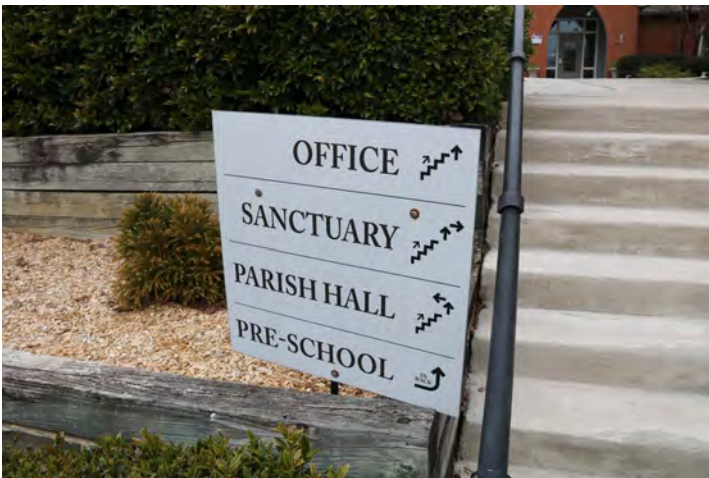
Wayfinding signage is helpful for directing guests

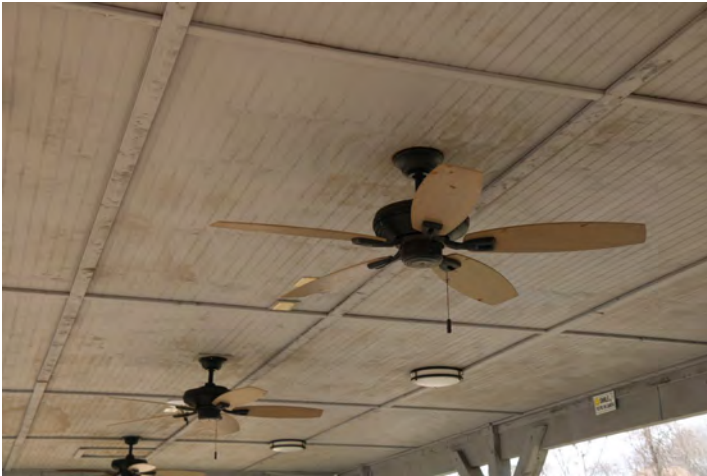
Regularly clean the ceiling and fans in pavilion

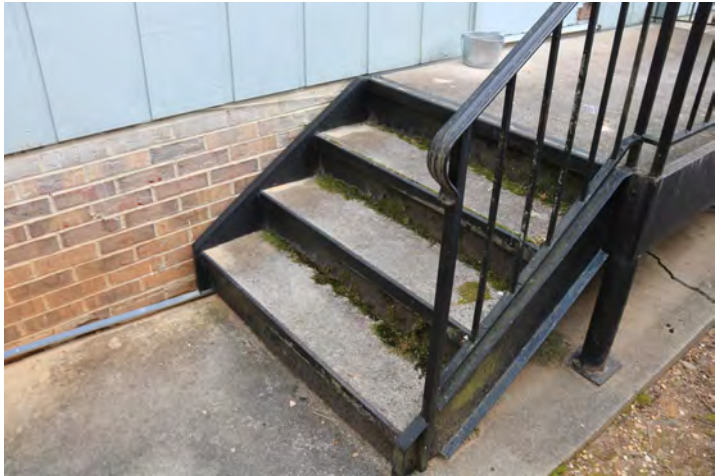
Clean organic material from steps

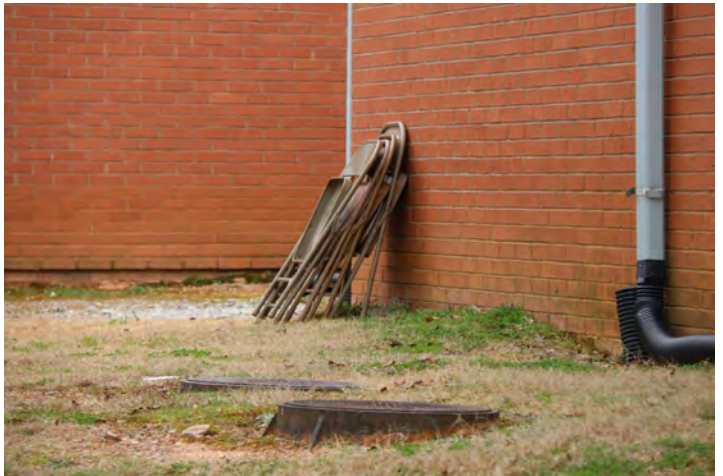
Relocate chairs to interior storage location

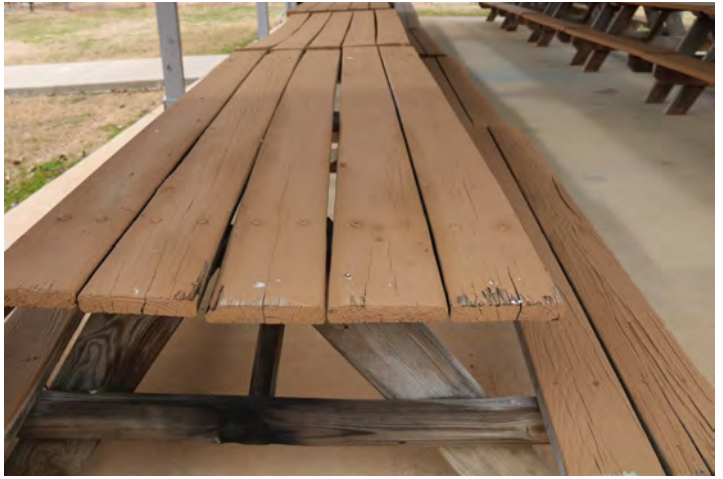
Replace worn lumber on picnic tables

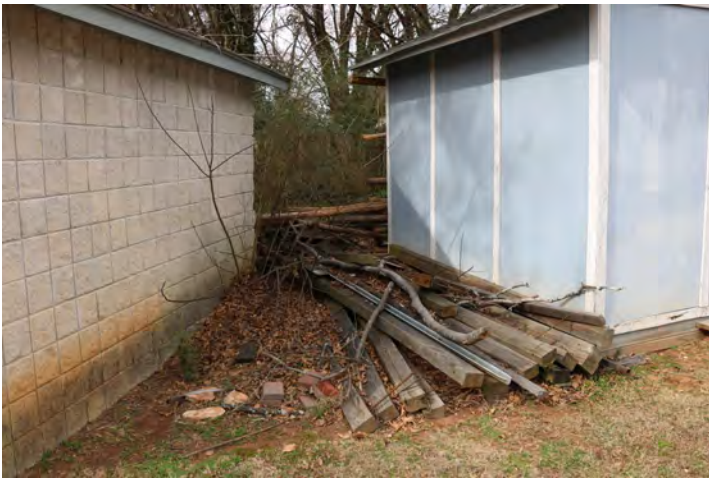
Remove lumber and landscape debris

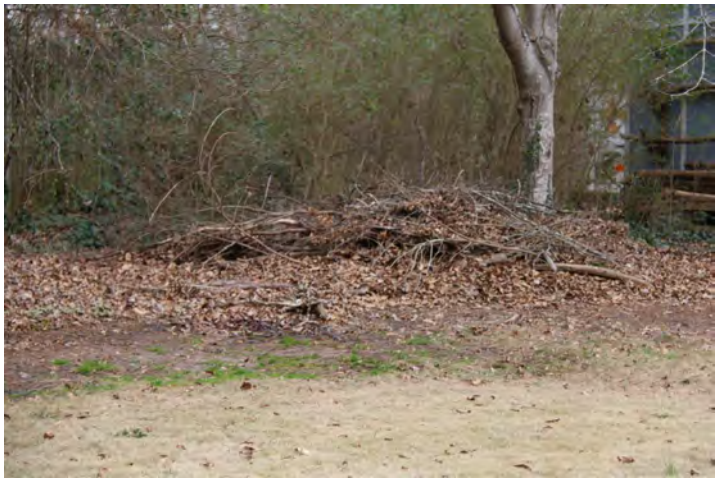
Remove landscape debris piles

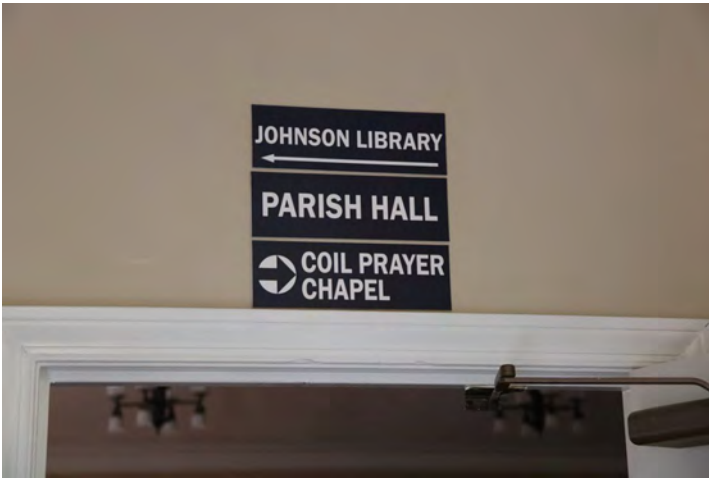
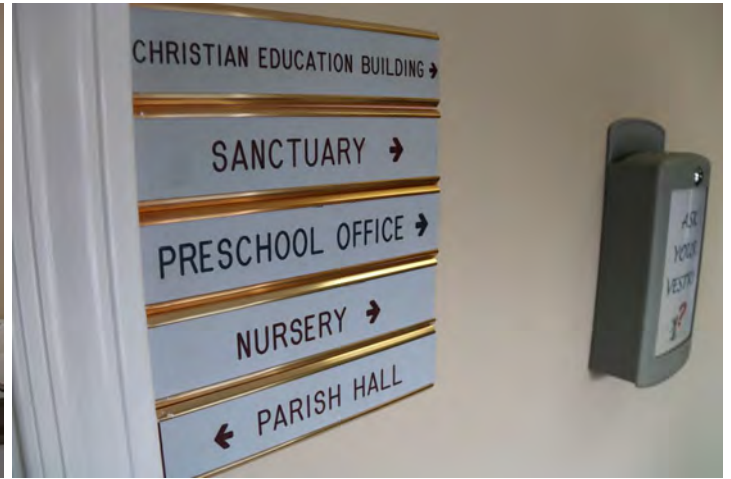
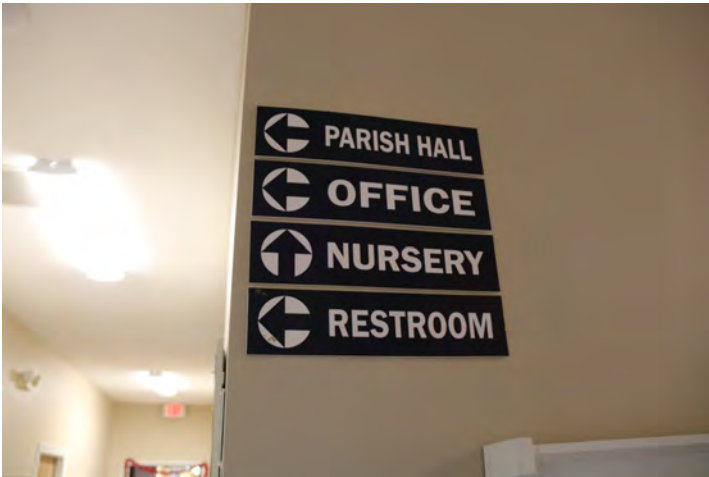
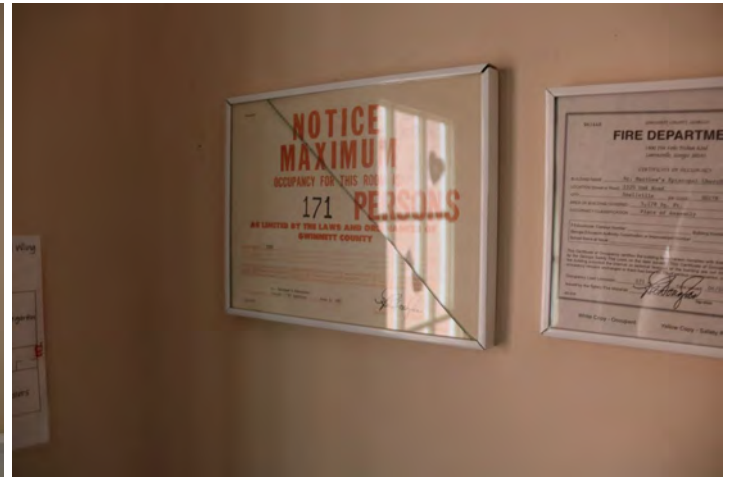
St. Matthew's facilities are equipped with abundant and strategically positioned wayfinding signs, facilitating easy navigation for guests without the need for assistance. However, it was observed that an occupancy sign has broken glass in the frame, which we recommend replacing as soon as possible.

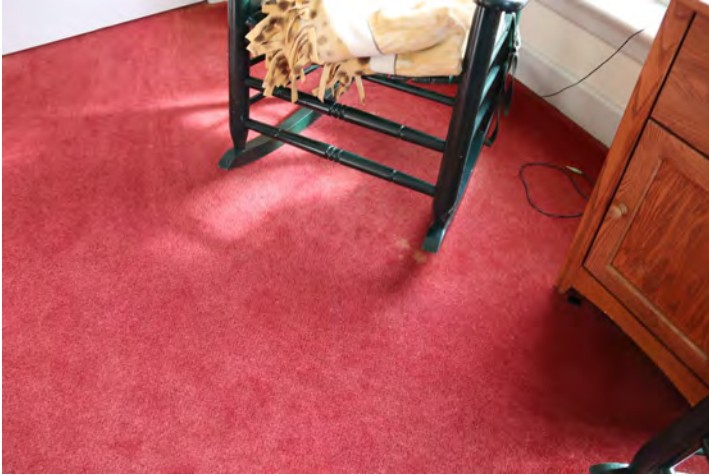
Stained and discolored carpet

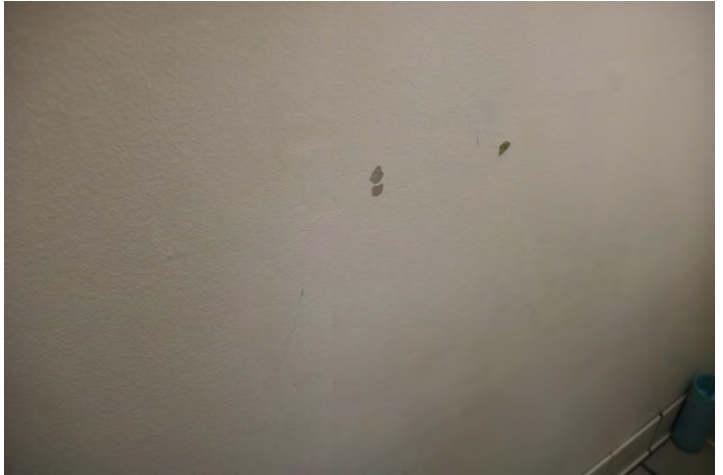
Chipped paint

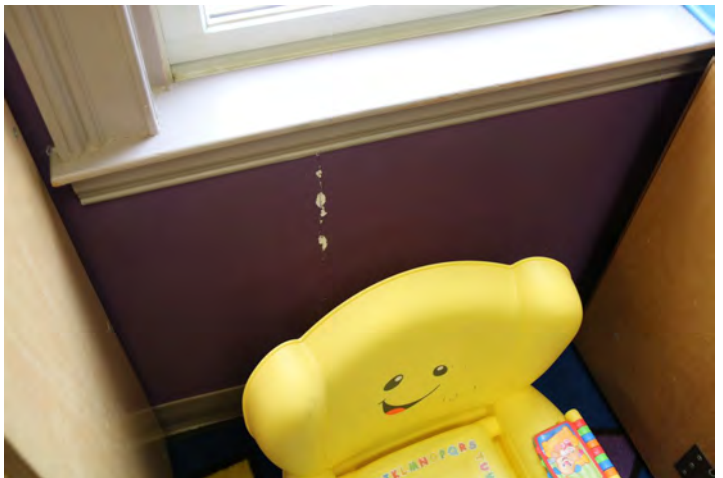
Chipped sheetrock

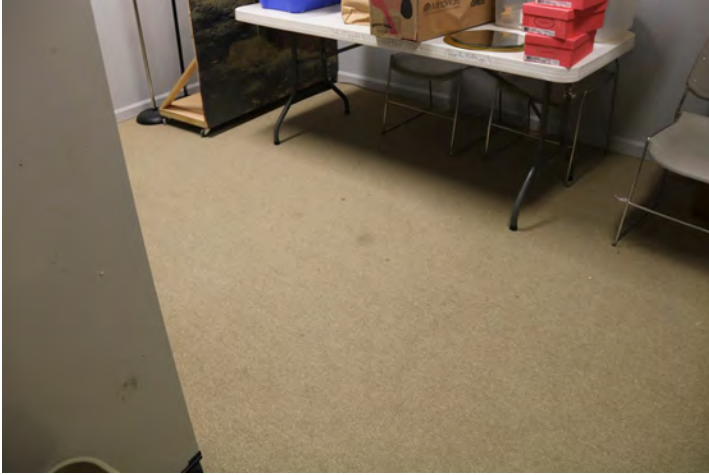
Stained carpet

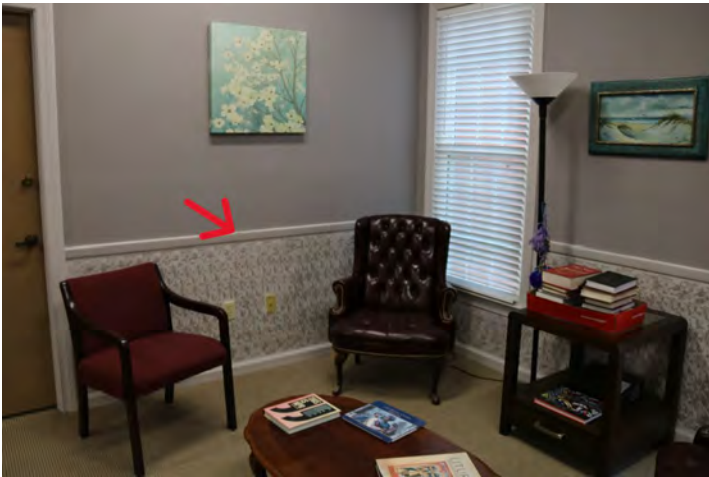
Nicked chair rail

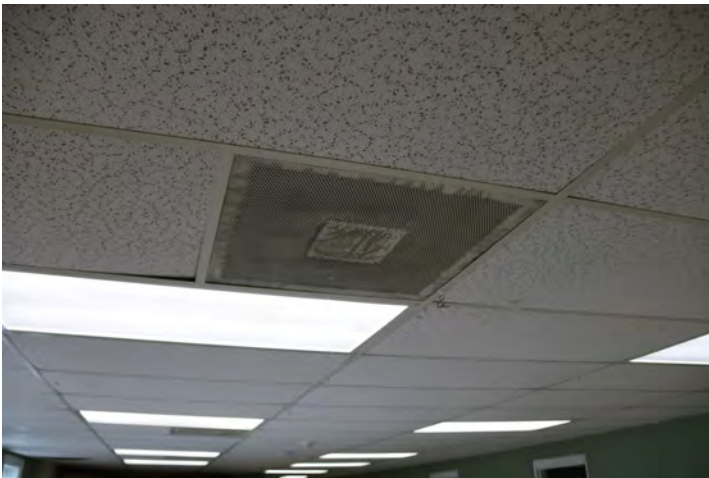
Clean ceiling vents regularly

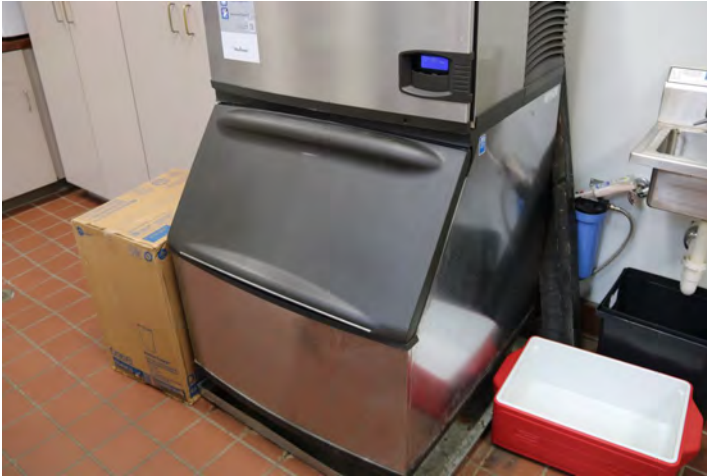
Clean exterior of ice maker

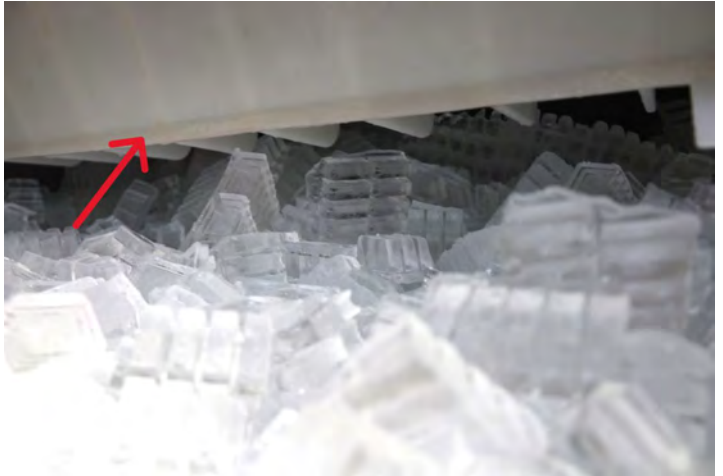
Clean ice machine to remove organic growth

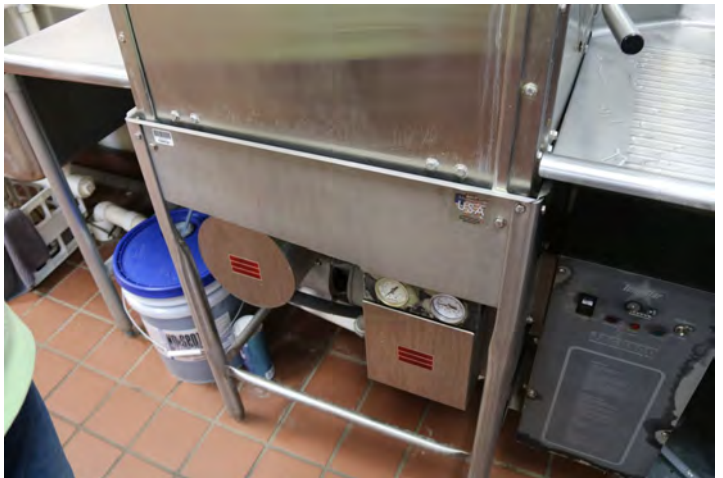
Clean exterior of dishwasher

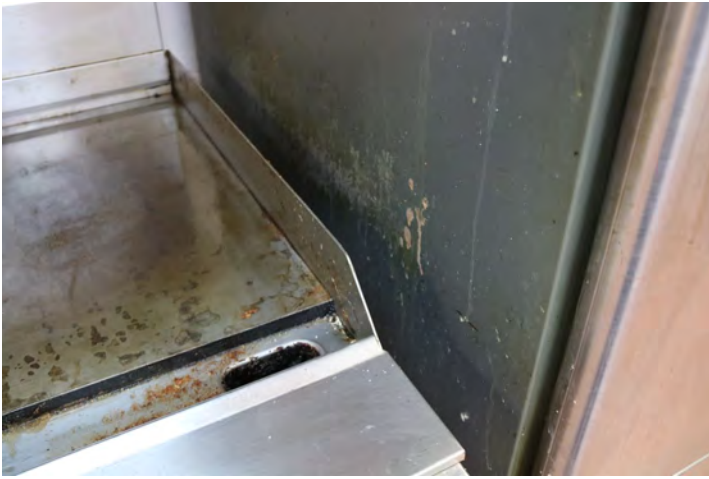
Clean grill top and surrounding areas

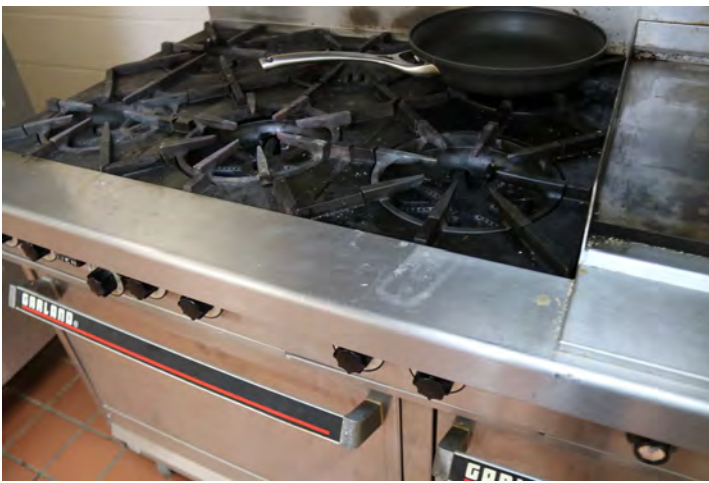
Clean exterior surfaces of stove and ovens

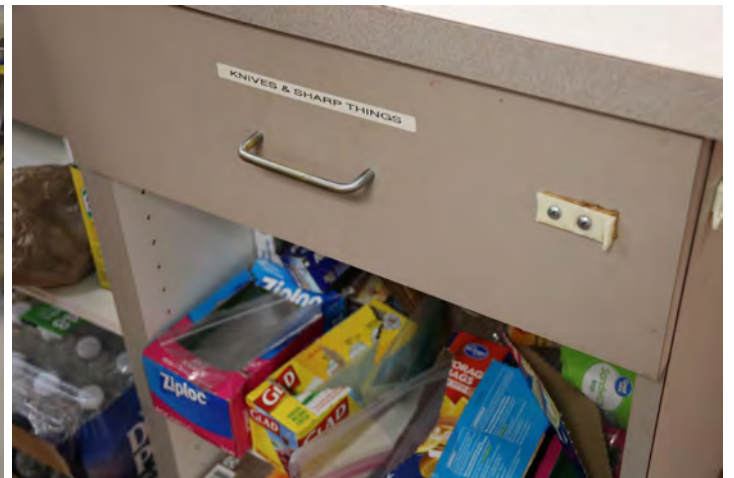
Broken safety latch on knife drawer

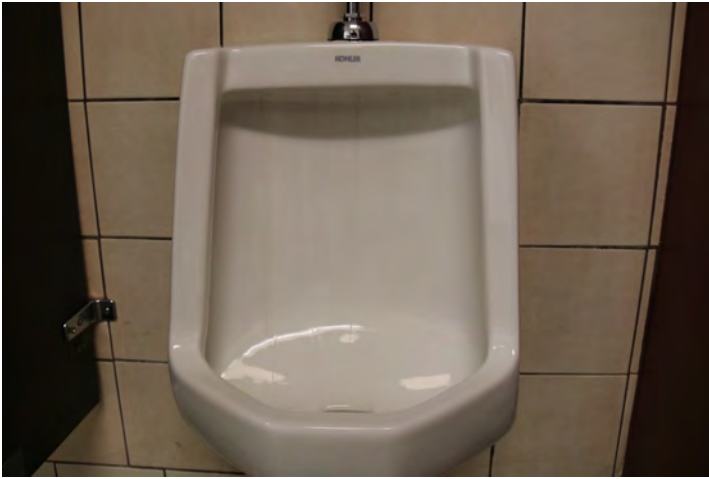
Dirty urinal

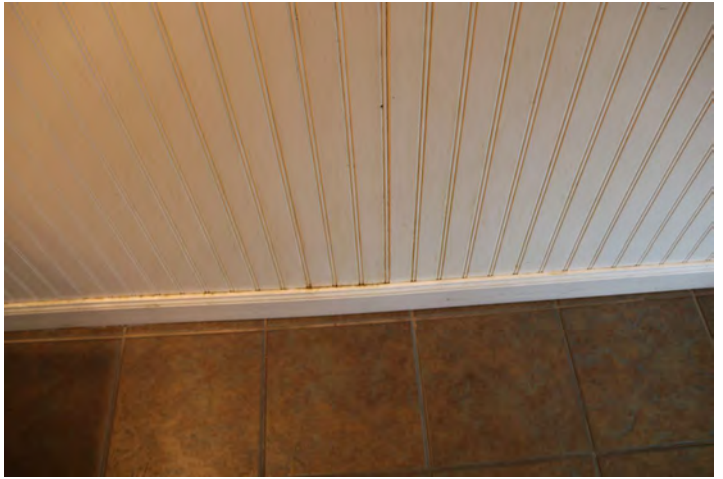
Dirty wainscot and base boards

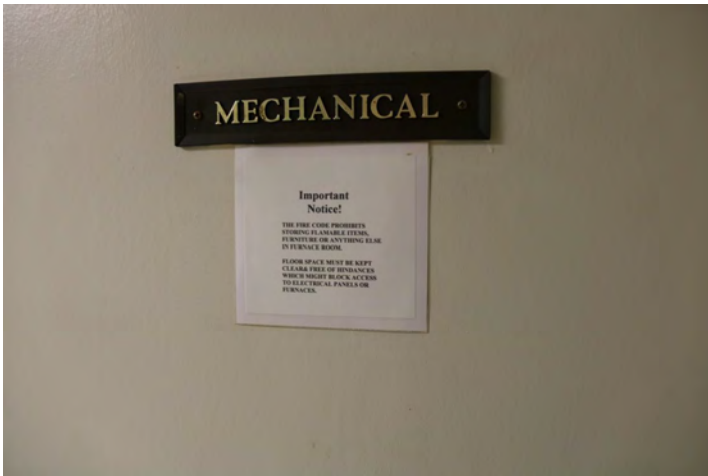
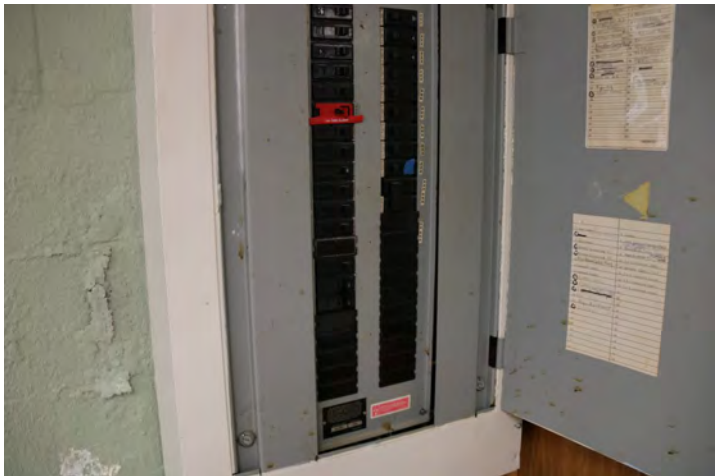
Furthermore, two concerns were raised regarding electrical panels located in publicly accessible areas. We recommend keeping the doors of these panels locked to deter unauthorized access. Additionally, we suggest repositioning the freezer in the kitchen to maintain access to the panel in case of emergencies.

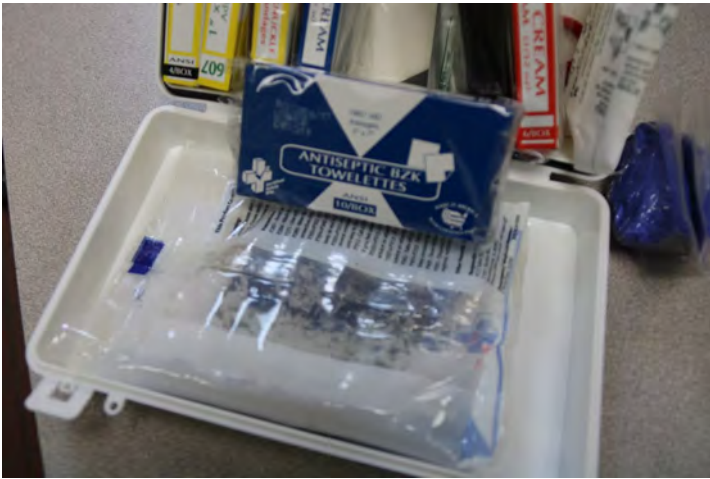
Life Safety Equipment - A first aid kit was observed in the facility, however it contained expired supplies. To ensure preparedness, we recommend replenishing all first aid kits with supplies that adhere to OSHA guidelines, specifically following the ANSI Z308.1-2015 standard for first aid supplies.

Expired first aid supplies (10/2019)

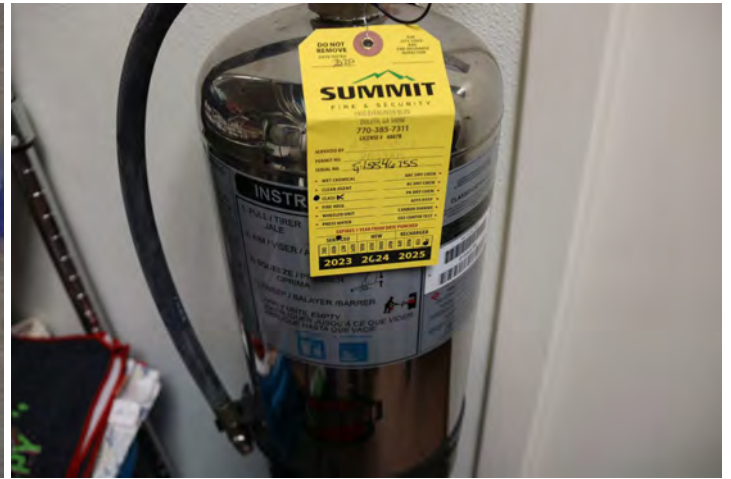
Current Annual Certification tag

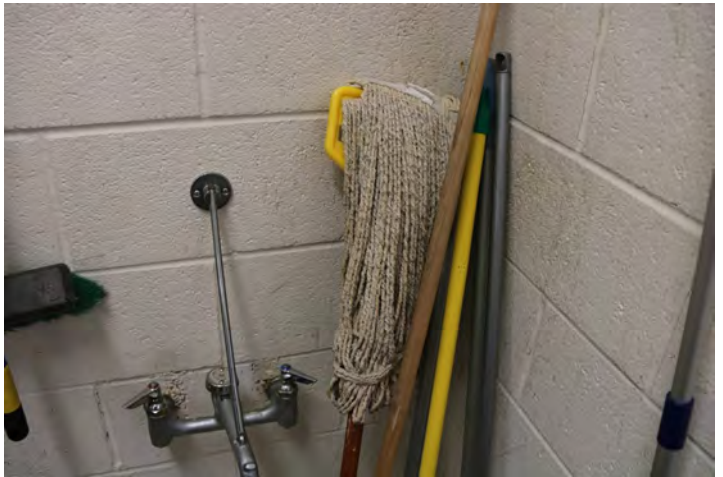
It appears that string mops have been frequently used as cleaning tools throughout the facility. However, it is important to note that string mops are not particularly effective in achieving the highest levels of cleanliness. To enhance overall cleaning efficiency, we recommend transitioning to a color-coded microfiber cleaning system, encompassing wiping cloths, flat mops, and dusters.

String mops should be replaced with microfiber
